Liquefaction-Induced Damage During the 2001 El Salvador Earthquake

Rolando ORENSE¹ · William VARGAS-MONGE² · José CEPEDA³

Key Words: soil liquefaction, earthquake damage, site investigation, lateral flow

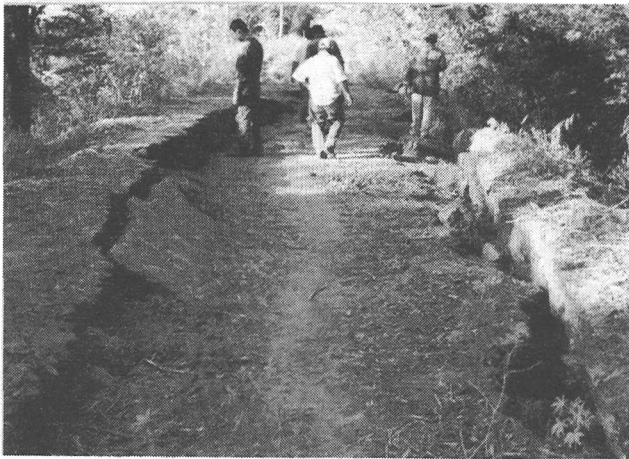
Figure 2: Damaged river dike in San Carlos Lempa

The northern section of the dike, with a length of about 8km, had been completed in 1999. Evidence of liquefaction, such as sand boils and ground cracks, were observed in the inland portion adjacent to the dike. In some portions of the dike, particularly at Sta. 6+500 and Sta. 6+105, longitudinal cracks were noted at the shoulder of the dike and at the crest. In addition, ground subsidence occurred by as much as 30cm in one location as shown in Figure 2.

Construction of the southern section of the dike started in March 2000, was stopped in May because of the onset of the rainy season, and finally was continued in early December. Thus, a portion of the southern end of the dike was still under construction when the earthquake occurred. In San Carlos Lempa, lateral spreading of about 2.5m occurred towards the river on the western bank. At this point, i.e., at Sta. 14+770, the dike alignment is closest to the river. Ground cracks, some as wide as 20cm, and vertical offsets by as much as 30cm, were observed near the riverbank. Eyewitnesses reported that one of the trucks used in the dike construction sank into one of

the cracks. Sand boils were observed sporadically at various locations on both sides of the dike. The loss of competent ground between the river and the dike now endangers the main body of the dike, especially during the rainy season.

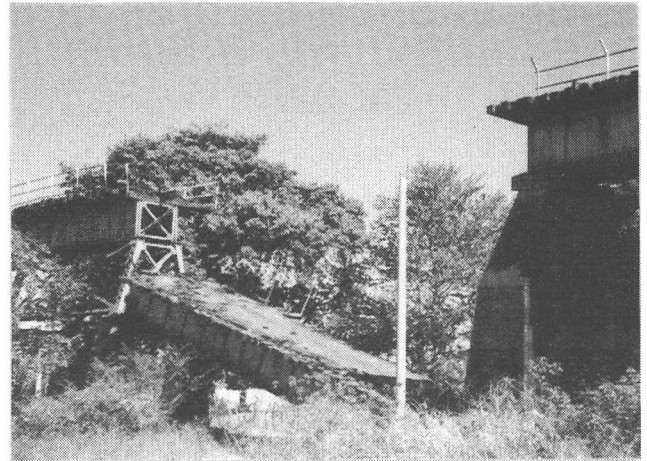
Figure 3: Fallen bridge girder in San Marcos Lempa

Upstream in the north, in San Marcos Lempa, one of the girders of an old railway bridge crossing Rio Lempa collapsed due to the lateral movement of the liquefied subsoil (see Figure 3). Ground cracks, some as wide as 20cm, and sand boils were observed in the vicinity of the fallen girder. Apparently, the lateral spreading of the ground, by as much as 1.2m in total, carried two of the bridge piers toward the river. The superstructure, which is relatively stiff, did not move sufficiently with the piers, resulting in breaking of each pier near the mid-section, apparently at the location of construction joints. Due to the discontinuity of the bridge girder at the location of the third pier, and possibly due to the short bearing length, the span west of this pier slipped off.

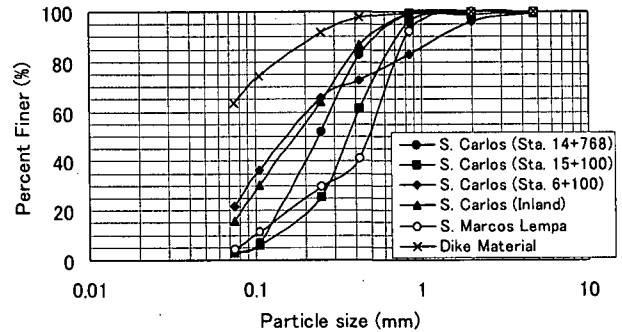
Figure 4: Grain size distribution curves of ejected sands and of dike material

the sand boils in San Carlos consist basically of poorly graded fine sands, with minimal gravel content (<4%). The fines content for the sand boils observed near Rio Lempa seem lower than those obtained at sites far from the river. On the other hand, the ejected sand sampled in San Marcos Lempa has almost uniform gradation with negligible fines content. Other characteristics of the erupted materials are given in Table 1.

The grain size distribution curve for the dike materials is also indicated in Figure 4. This curve serves as indication of the type of surface soil in the area, since such materials were used to construct the main body of the dike. Note from Figure 4 and Table 1 that these materials are predominantly clayey and silty materials, with 64% fines content.

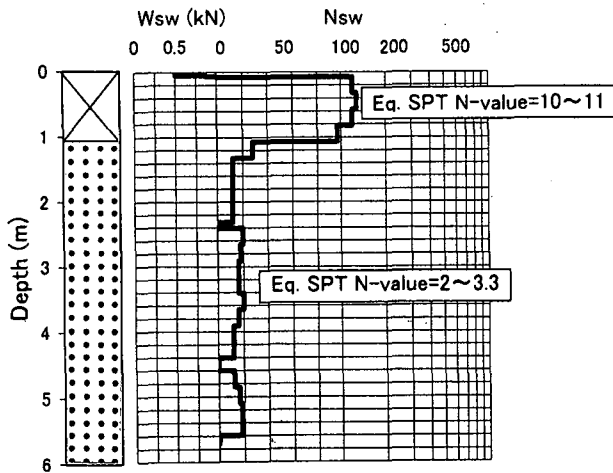
Figure 5: Results of Swedish sounding test in San Carlos Lempa

The first test was conducted in San Carlos Lempa, at the site between the dike under construction and the riverbank where lateral spreading was observed. The result is shown in Figure 5, which shows that a 1.1m thick of backfill material is underlain by a soft sandy layer with an equivalent SPT N-value between 2~3.3. The actual depth of the loose deposit was not verified because of the limited number of rods brought to the site. It was estimated that the level of water in the river was about 2m lower than the ground surface.

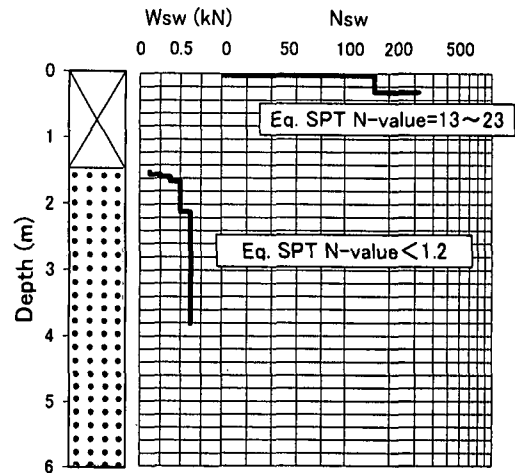
Figure 6: Results of Swedish sounding test in San Marcos Lempa

The second test was performed near the fallen bridge girder in San Marcos Lempa. At the initial test site located about 10m from the river bank, the sounding test showed a very hard surface layer, which made the penetration very difficult, as shown in the upper portion of Figure 6. An equivalent SPT N-value of 13~23 was computed at this site. The test site was then moved, this time between a vertical slope at the riverbank and the waterline. At this location, a 1.5m thick surface soil was exposed, and this is considered to be the thickness of the surface layer. The exposed surface soil was highly cemented. Sounding test was continued from the ground surface near the waterline, and the penetration rod simply sank into the deposit with weights less than 1kN (100kgf), indicating a very soft deposit with equivalent SPT N-value less than 1.2. Again, the total depth of this loose deposit was not confirmed because the rod hit a hard object, presumably gravel, which prevented the full-penetration into the stratum. At this point, the test was abandoned. When the rods were retrieved, gray-colored sand particles were

observed adhering to the surface of the rods.
