# MECHANISM OF DAMAGE TO SHIWEI BRIDGE CAUSED BY 1999 CHI-CHI EARTHQUAKE

The Shiwei Bridge in Taiwan was extensively investigated in order to determine the reasons for its failure during the 1999 Chi-Chi Earthquake. Our field investigation revealed no evidence of horizontal displacement in any of the bridge's piers, although the foundations of the piers were rotated. Two possible scenarios for the failure of the girders are proposed: 1) when the foundations rotated, the distance between the piers became greater than the length of the girder, causing the girders to fall; or 2) the direction of the seismic motion was perpendicular to the axis of the bridge, causing the girders to rotate and fall.

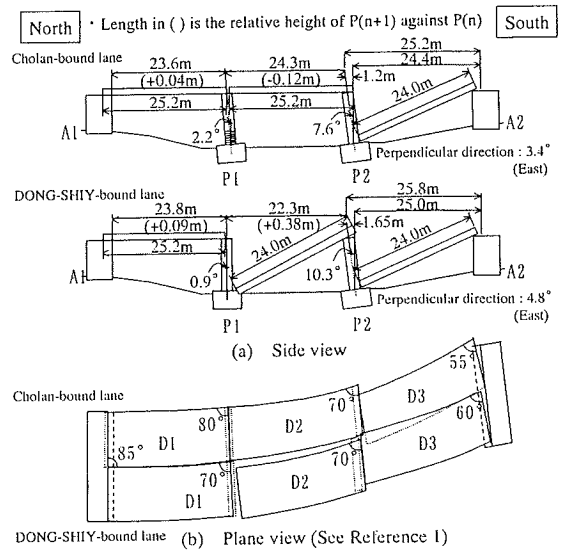
Fig.3 Damage to SHI-WEI Bridge and Measurements

The damage to the Shiwei Bridge is shown in Figs. 3 and 4. On the Dongshyh-bound roadway, the north ends of girders D2 and D3 fell from piers P1 and P2, respectively. Similarly, on the Cholan-bound roadway, the north end of girder D3 fell from pier P2. On both roadways, girders D3 smashed into the parapets of abutments A2, the bearing pads dropped from the bridge seats, and the shear keys were damaged. This damage is shown in Fig. 5.

Figure 3 shows the distances between the substructures and the lengths of girders. These values were obtained during our field survey using

between piers P2 and abutments A2, which jointly an optical surveying instrument. The distances support girders D3, are 25 m for the Dongshyh-bound roadway and 24.4 m for the Cholan-bound roadway. It is obvious that girders D3 on both roadways fell because the girders (24 m) were shorter than the distances between the substructures. In contrast, girder D2 on the Dongshyh-bound roadway fell from the pier despite the fact that the 24 m girder was longer than the 22.3 m distance between piers P1 and P2.

Girders D3 on both roadways probably fell due the significant displacement of piers P2 toward the north. This displacement was triggered by ground deformation and the ensuing rotation of the foundations. This assumption is substantiated by the fact that, when the distance between pier P2 and abutment A2 before the earthquake (24 m) is added to the horizontal displacement at the top of pier P2 (1.64 m for the Dongshyh-bound roadway, and 1.2 m for the Cholan-bound roadway), the resulting length is nearly equal to the distances between pier P2 and abutment A2 after the earthquake (25.8 m for Dongshyh-bound roadway and 25.2 m for the Cholan-bound roadway).

The same assumption applies to the case of piers P1 and P2. The distance between piers P1 and P2 before the earthquake was 24 m for Dongshyh-bound roadway and 25.2 m for Cholan-bound roadway. If the displacement at the top of the pier, caused by rotation of the pier, is deducted from these distances, the resulting lengths roughly equals the distance measured after the earthquake (22.3 m for Dongshyh-bound roadway and 24.3 m for the Cholan-bound roadway).

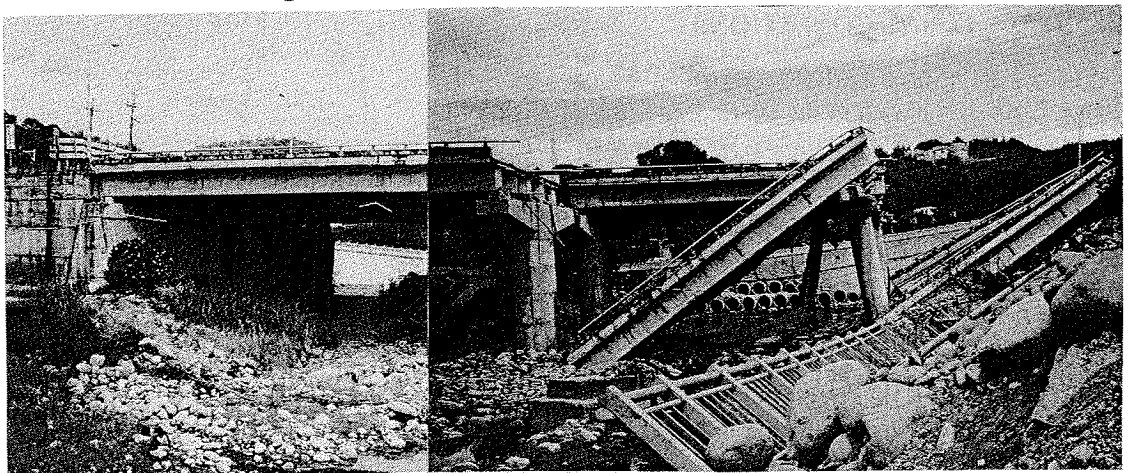
Fig.4 Damage to SHI-WEI Bridge

The riverbank beside abutment A2 suffered significant slope failure, as seen in Fig. 4. According to one report, the slope failure was caused by movement along the Chelungpu fault (1).

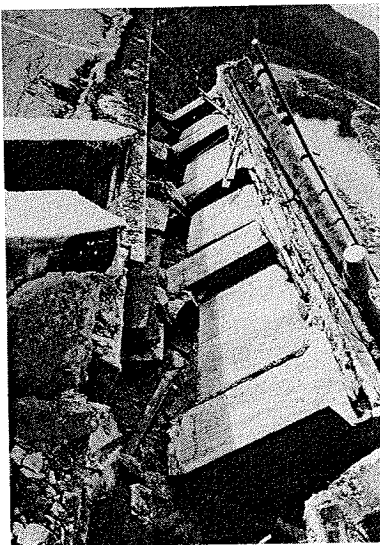
Fig.5 Damage to a shoe near abutment A2

As shown in Fig. 3, Shiwei Bridge is a skew bridge that curves at angles ranging from 55° to 85°. Trace evidence suggested that the bridge had been exposed to seismic motion in the direction perpendicular to the bridge, as well as along the bridge axis. This can be seen in from Fig. 5. This led us to investigate pier P2 on the Dongshyh-bound roadway to see if it underwent rotation due to seismic motion in the perpendicular direction, causing girder D2 to fall.

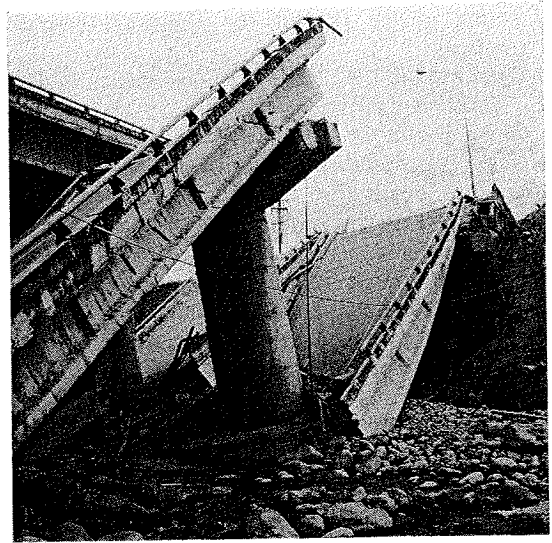
Fig.6 Tilting of Pier P2 towards the bridge axis direction on the DONG-SHYH-bound lane

On the Dongshyh-bound roadway, pier P1 sustained no serious damage but was tilted slightly (about  $0.9^\circ$ ) toward abutment A1. Pier P2 also did not suffer any significant damage to its column, but its foundation rotated considerably. As a result of the rotation, pier P2 tilted  $10.3^\circ$  toward pier P1 and  $4.8^\circ$  in the direction perpendicular to the bridge axis. This is shown in the photographs in Figs. 6 and 7.

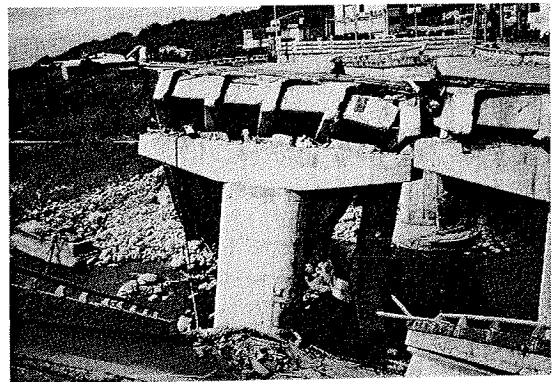
Fig.7 Tilting of Pier P2 toward the perpendicular direction on the DONG-SHYH-bound lane

Pier P1 on the Dongshyh-bound roadway showed very little residual displacement, but the pier P2 on the same roadway inclined  $4.8^\circ$  in the direction perpendicular to the bridge axis, which results in a 0.75 m displacement toward the east when measured at the top of the pier. It is therefore assumed that this displacement also worked to allow rotation of the girder, in addition to permitting displacement in the direction of the bridge axis.

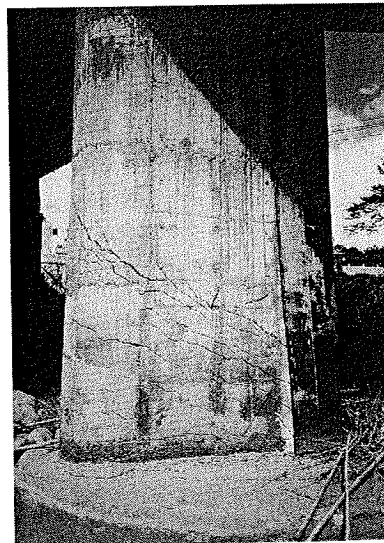
Fig.8 Damage to Pier P1 on the Cholan-bound lane

Pier P1 on the Cholan-bound roadway suffered shear and flexural cracking in the east-west direction at a height of about 2 m from the ground. The cover concrete on the north side of the pier bottom broke loose and fell, as shown in Fig. 8. This pier tilted about  $2.2^\circ$  toward abutment A1. Pier P2 on the Cholan-bound roadway did not suffer any serious damage to its column, but its foundation rotated  $7.6^\circ$  toward pier P1 and  $3.4^\circ$  toward the east. The pier also leaned toward the north.

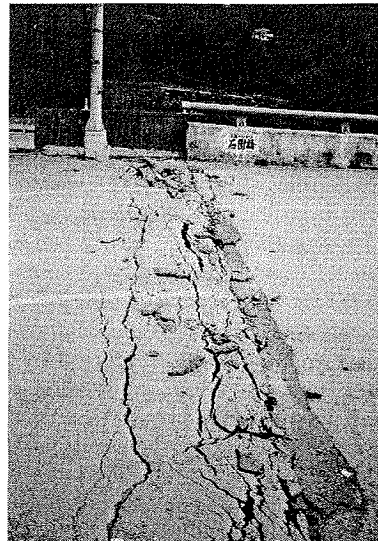
Fig. 9 Damage around abutment A1 on the Cholan-bound lane

Girder D2 on the Dongshyh-bound roadway fell from the pier despite the fact that the length of the girder was greater than the distance between piers P1 and P2. This was probably because the seismic motion generated inertia force in girder D2 and this force acted in the direction of abutment A2 before girder D3 fell. Subsequently, because of the short length of its seating, girder D2 was pushed toward abutment A2. The fallen girder is shown in Fig. 10. Evidence of such a large inertia force includes such observed damage as spalling of the concrete and flexural and shear cracking at the bottom of pier P1 on the Cholan-bound roadway, and the damage to abutments A1 and A2 caused by the girders smashing into the parapets. Girder D2 on the Cholan-bound roadway did not fall, probably because 1) the seismic energy was absorbed by the colliding girders, 2) the damage to the pier P1, and 3) the rise of the road surface at abutment A1 caused by the girder being pushed about 0.4 m toward the north. This resulted in a seismic response that was smaller than that of the Dongshyh-bound roadway. The other girder D2, which did not fall, is seen in the background of Fig. 9.

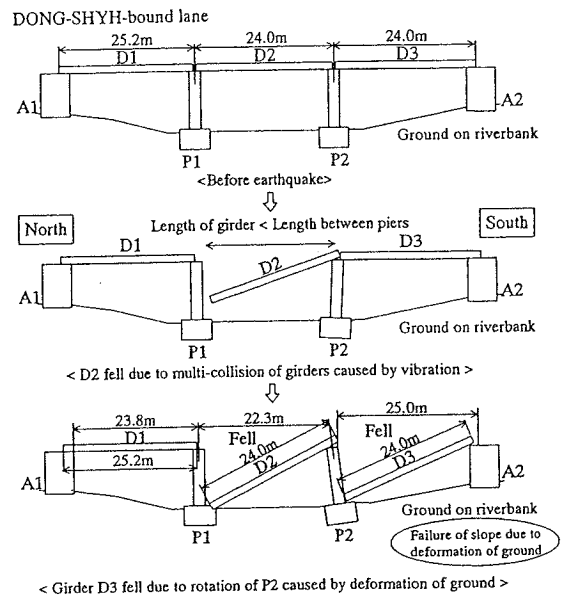
Fig.10 Possible mechanism for fallen girders on the DONG-SHYE-bound lane

Since girder D2 was supported by pier P1 and the northern portion of the girder fell, it is presumed that rotation occurred around the rotational axis, which is located at Point A at the end of the girder on the obtuse angle side above pier P2. Figure 11 shows a schematic description of a configuration of the girder that can undergo geometric rotation.

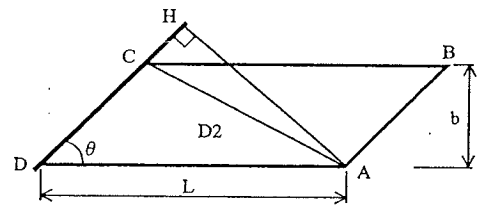
Fig.11 Determination of rotation possibility

If the end point A of the girder on its obtuse angle side is considered as the center of rotation, rotation can occur when  $DC \leq DH$  is held on the opposite side. Figure 11-C shows this case. Namely, the point C moves to the inside of the side DC and the girder begins to rotate.

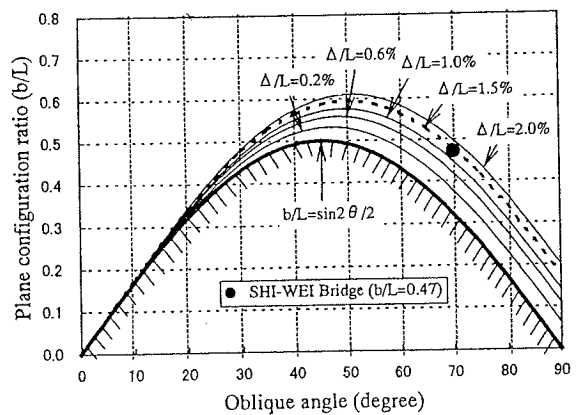
Fig.12 Relationship between an oblique angle( $\theta$ ) and a plan configuration ratio( $b/L$ )

Figure 12 shows the relationship between the configuration ratio ( $b/L$ ) and the oblique angle ( $\theta$ ) of a skew bridge that can undergo rotation. Here, 'b' is the width of the superstructure, and 'L' is the girder length. The area enclosed by slashes satisfies Equation (2) and is the range of the girder that can undergo rotation(2). The ● symbol in Figure 12 indicates the relationship between the configuration ratio ( $b/L = 0.47$ ) and the oblique angle ( $=70^\circ$ ) of girder D2 on the Dongshyh-bound roadway. As its position is located outside the area where the girder can fall, girder D2 could not rotate geometrically, if the positions of the girder and the piers remained unmoved during the earthquake.

However, as stated earlier, it is known that seismic forces acted not only in the direction perpendicular to the bridge but also in the direction of the bridge axis. If  $\Delta (= \Delta_1 + \Delta_2)$ , the total of the space at both ends of girder D2, is assumed to have increased, due to seismic forces, by about 0.35 m ( $\Delta/L = 1.5\%$ ) from the original space before the earthquake, the area in which the girder can fall is the area enclosed by the heavy dotted line ( $\Delta/L = 1.5\%$ ) in Fig. 11 from the condition equation (2). The ● indicates the relationship between the configuration and the oblique angle of girder D2, subsequently lies within the area in which the girder can fall, which means the girder can rotate geometrically.
