## Brief Review of the June 23, 2001 Atico Earthquake, Peru

Kazuo KONAGAI<sup>1</sup>, Kimiro MEGURO, Junichi KOSEKI, Kenichi OHI,  
Shunichi KOSHIMURA<sup>2</sup>, Miguel ESTRADA<sup>1</sup>, Jorgen JOHANSSON<sup>1</sup>,  
Paola MAYORCA<sup>1</sup>, Ruben GUZMAN<sup>1</sup> and Tomohiro KIMURA<sup>3</sup>

Atico Earthquake occurred off the coast of southern Peru, about 175 km west of Arequipa or about 595 km southeast of Lima at 4:33 PM EDT on Jun 23, 2001 (3:33 PM local time in Peru). In this earthquake, total 41,394 dwellings were reportedly destroyed or heavily damaged. In urban areas, more than 80% of the housing infrastructures are made of masonry and adobe/tapial while in rural areas almost 70% of the dwellings are made of the latter. Though tragic, the death toll was fairly light considering the magnitude of this earthquake, the largest one to occur anywhere in the world in the past 25 years, and the damage seemed to be greatly localized even in a small area. This report outlines the findings obtained through the reconnaissance survey and some comments by some individuals

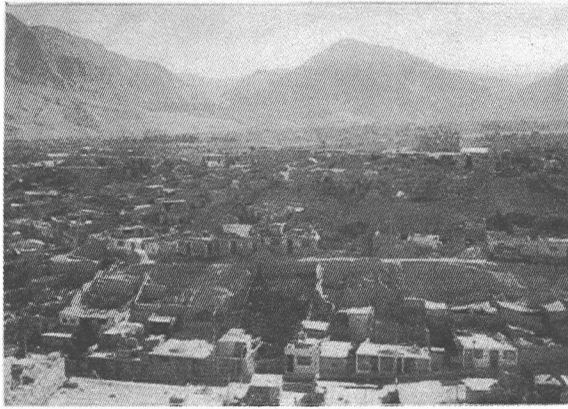
Figure 4 View of the terrace next to San Francisco hill

Moquegua was the hardest hit city by this earthquake. A number of adobe buildings collapsed in the downtown area and many others sustained heavy damage. A thin mountain ridge, the northeast extension of a sand rock terrace rising behind the central area of Moquegua city, dips gently towards northeast. This ridge is densely covered with adobe dwellings, and the damage to dwellings was the severest there (Figure 4).

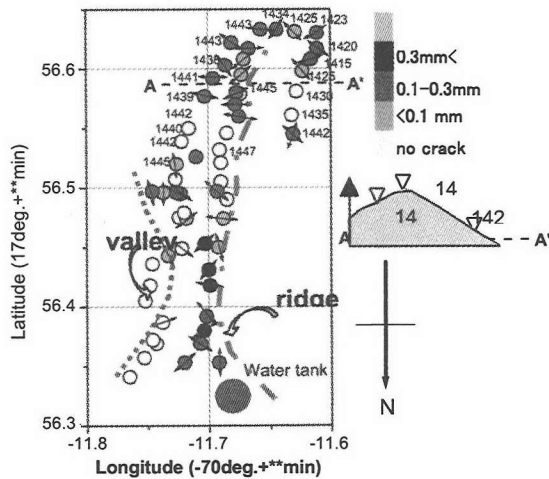
Figure 5. Distribution of cracked utility poles in San Francisco area, Moquega: Numbers put by circles show elevations of utility poles measured by using a GPS receiver.

Figure 5 shows the observed distribution of crack intensities. Arrows indicate the inferred directions of strong ground motions. In this figure, the first, second and third lines from left to right lined up with the inspected utility poles are streets along a narrow valley, along the ridge and on the other hillside, respectively. It is noted that no utility pole along the valley was cracked while those around the highest peak of the ridge near a water tank were severely cracked. This contrast suggests that some topographical effect must have been responsible for amplifying ground motions. The arrows along the ridge show that the effect was more pronounced in the transverse direction of the ridge.

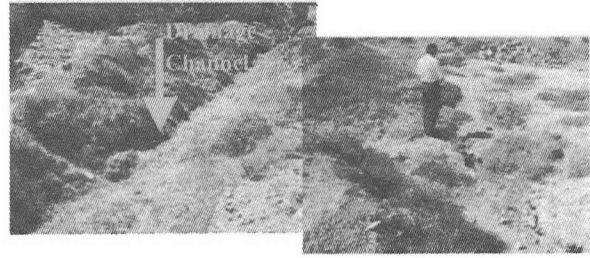
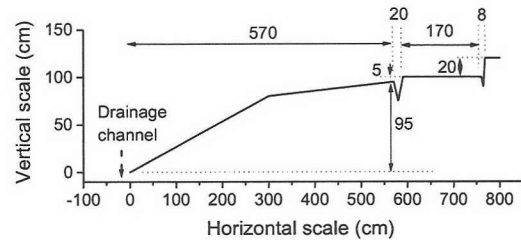
Figure 8 Liquefaction-induced lateral spreading (Lara, Socabaya District, Arequipa)

(a) Lateral spreading toward drainage channel

(b) Cross-section of lateral spreading at line A-A' in Figure 3.2

Liquefaction occurred in a lowland of Arequipa (at Lara, Socabaya district; latitude of  $S16^{\circ}27.271'$ , longitude of  $W71^{\circ}32.148'$ , and elevation of 2288 m). It induced lateral spreading of ground as typically shown in Figure 8. The plan of the affected area is shown in Figure 9. The lateral spreading caused collapse of brick walls (Figure 10a) and clogging of drainage channels that had an original opening width of about 50 cm (Figure 10b). Several cracks were also formed in almost level ground at a horizontal distance of about 25 m from the closed drainage channel (Figure 3.3c). It should be noted that there was no damage to concrete pipes with a diameter of about 50 cm used for the drainage channel to under-pass an unpaved road (Figure 9).

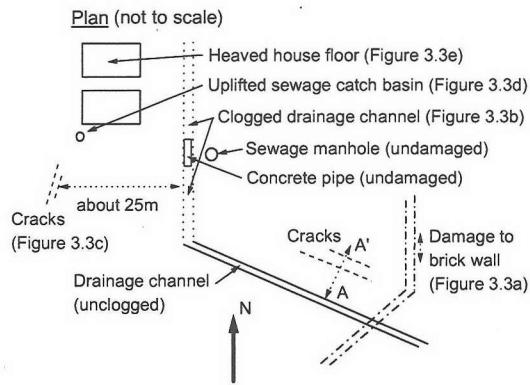
**Figure 9** Plan of affected area  
(Lara, Socabaya District, Arequipa)

It should be noted that a sewage manhole with a diameter of about 60 cm located near the undamaged concrete pipe (Figure 9) did not suffer any damage or uplift. In contrast to this, the uplifted sewage catch basin (Figure 10d) had a diameter of about 40 cm and an original depth of about 50 cm below the ground surface, suggesting that its bottom was located above the ground water table even before the earthquake. In addition, it is reported that extensive sand boiling took place around the uplifted catch basin. This uplift damage was, therefore, estimated to have been caused by the upward forces exerted by the boiling sands, not by the loss of stability against uplift due to generation of excess pore water pressures in the liquefied soils.

Detailed investigation is required on the soil conditions at this site, which will provide useful information on liquefaction susceptibility in lowland areas in Arequipa.

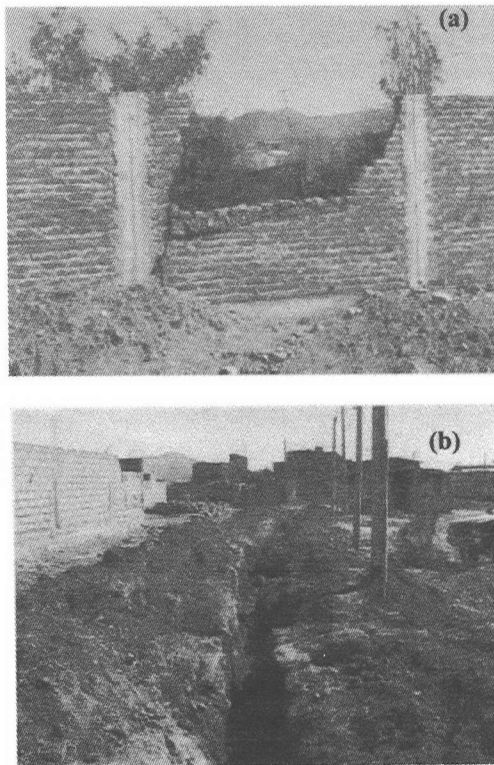
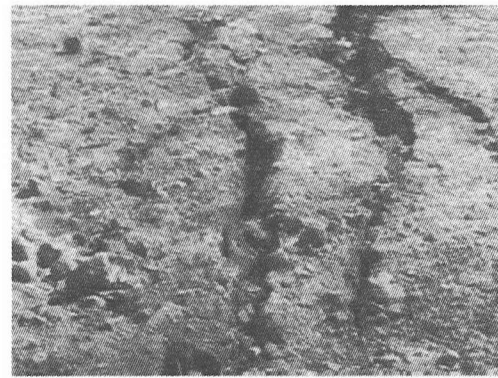
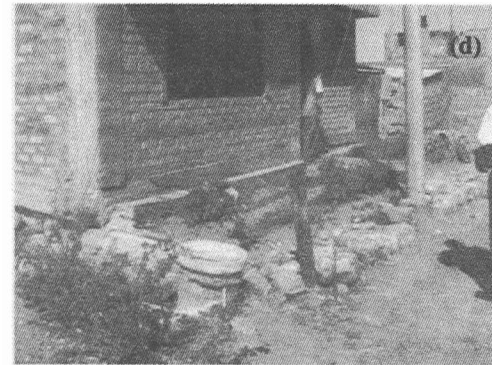
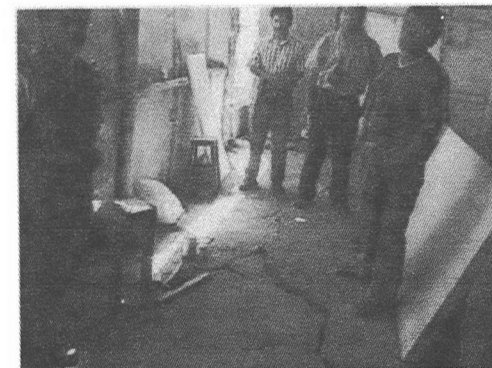
**Figure 10** Liquefaction-related damage  
(Lara, Socabaya District, Arequipa)

In the affected area, one house suffered uplift of sewage catch basin by about 20 cm (Figure 10d) and heaving of house floor due to sand boils (Figure 10e, next page). The boiled sand was black under wet state and white under dry state, possibly containing some volcanic or organic components, which also contained coarser particles having a maximum diameter of about 5 mm. It is reported that the heaving took place during the earthquake shaking. It was accompanied by additional ejection of water that lasted for about 1 day, which may have been affected by the re-excavation work of the closed drainage channel.

- (a) Collapsed brick wall
- (b) Re-excavated drainage channel that was clogged with spread soil
- (c) Cracking in ground surface located at horizontal distance of about 25 m from drainage channel
- (d) Uplift of sewage catch basin
- (e) Heave of house floor due to sand boil

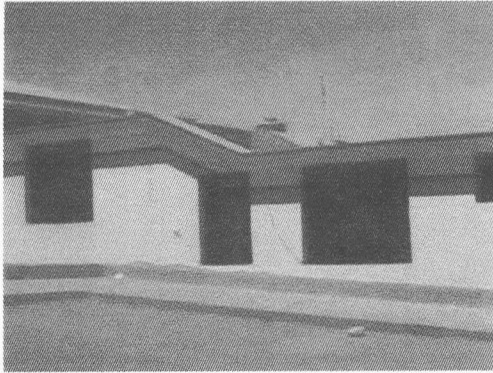
**Figure 11** Damage to health center constructed on expansive soil layers (San Antonio, Moquegua)

At San Antonio in Moquegua, one health center constructed on expansive soil layers suffered extensive cracks in the walls and floors (**Figure 11**). They had been formed before the earthquake, which were not worsened by the earthquake. Similar damage to adjacent houses was also observed. It is reported that the expansive soil layers were activated by water leaking from sewage pipes installed in the affected area.

In Moquegua, a plan of developing a new residential area for those who lost their houses in the severely damaged area (San Francisco) is under way. In order to avoid any damage in the newly developed area due to the expansive soils, it is required to establish procedures for detecting the existence of expansive soil layers and for evaluating their effects on buildings and underground pipes.

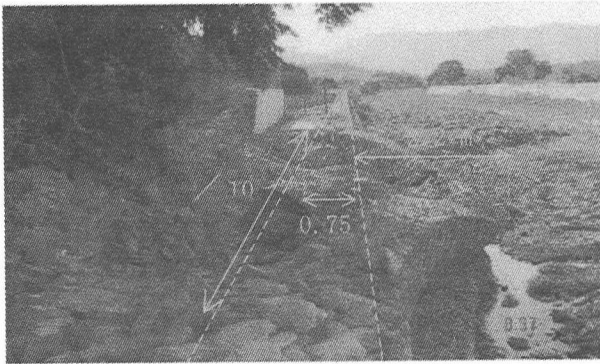
**Figure 12.** Deformed Gabion wall

**Figure 12** shows a gabion wall that even after undergoing around 44 % (2.2/5) shear strain in the vertical plane still has not ruptured. This is good example of the ductility of Mechanically Stabilized Earth structures. (Photo taken at the masonry factory in Moquegua, below the hotel El Mirador).

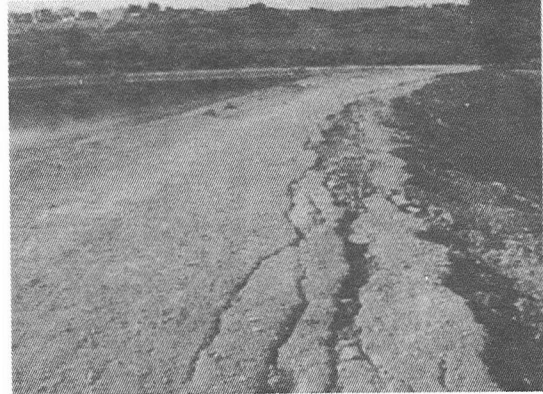
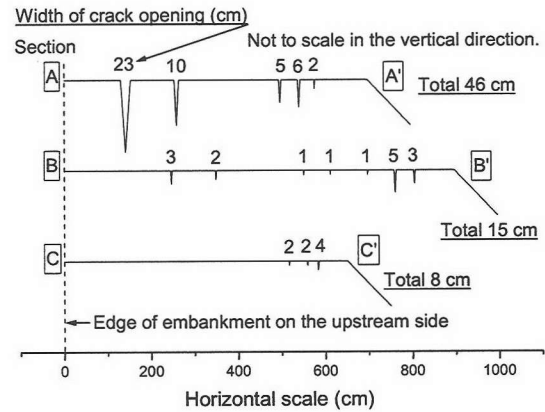
**Figure 14.** Longitudinal cracks

**Figure 13** shows a plan of two oxidation ponds for sewage treatment in Moquegua. The upper and lower ponds have a capacity of 21000 and 13000 m<sup>3</sup>, respectively, and have been cleaned every ten years. Their bottom is sealed with clay layer. By the earthquake, the embankment on the downstream side of the lower pond suffered cracking in its crest (**Figure 14, left**).

The total opening width of the cracks amounted up to 46 cm at maximum (Figure 14, right), and the residual settlement at the embankment shoulder was about 10 to 20 cm. In addition, the embankment between the upper and lower ponds became partly wet (Figure 15), suggesting a sign of piping. This location corresponds to a boundary between the original embankment constructed 40 years ago and the newer embankment re-constructed 6 years ago.

After the earthquake, in order to avoid instability of these embankments, the water level in both ponds were lowered by about 1 m. In order to cope with the current influent flow rate of 120 liters per second, which exceeds the design flow rate of 38 liters per second, the oxidation period had to be reduced down to 5 hours from the design value of 10 hours. These operations resulted into poor quality of treated water, which was used for irrigation purposes. Because the pipes to distribute the treated water were also damaged by the earthquake, it leaked into the adjacent Osmore River, affecting the quality of the river water.

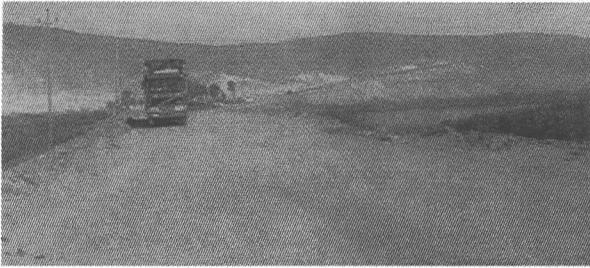
**Figure 16:** Pan American Highway Pavement removed after damaged due the earthquake (looking in Southbound direction).

At the 1213 km of the Pan American Highway the ground shaking damaged the pavement so much that it had to be removed to allow the traffic to pass (Figure 16) and heavy traffic was redirected to another route. The white rail side guard along the road buckled severely due to the large soil deformations as seen on the right side of Figure 17. The large ground deformations may have been a combination of a basin effect and soft soil layers. The damaged part of the road is situated in an alluvial valley and similar road damage was observed in other alluvial valleys along the Pan American highway between Tacna and Moquegua.

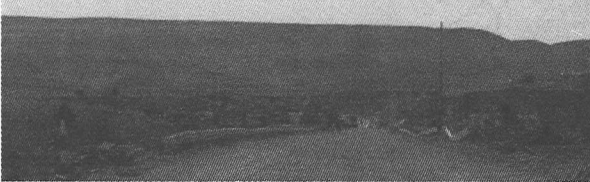
**Figure 17:** Buckled side guard (looking in Northbound direction).

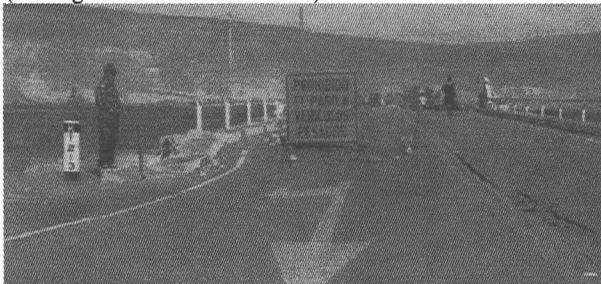
**Figure 18:** Settlement of bridge approach and cracking of road. Only one lane is open for traffic (looking in southbound direction).

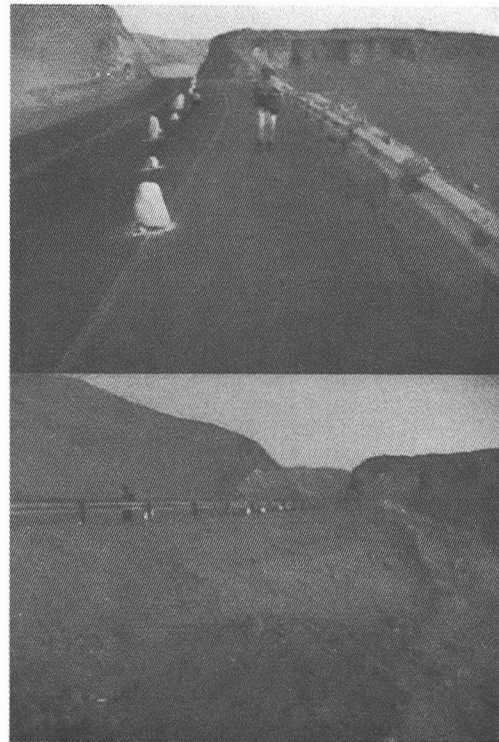
**Figure 19** Damage to road embankment (Pan American Highway between Moquegua and Tacna)

Some road embankments along the Pan American Highway between Moquegua and Tacna, and between Arequipa and Moquegua were damaged. The embankment shown in Figure 19 had a height of about 30 m, which suffered residual settlement of about 5 cm over a length of 72 m with cracking in the pavement having a maximum width of about 30 cm.

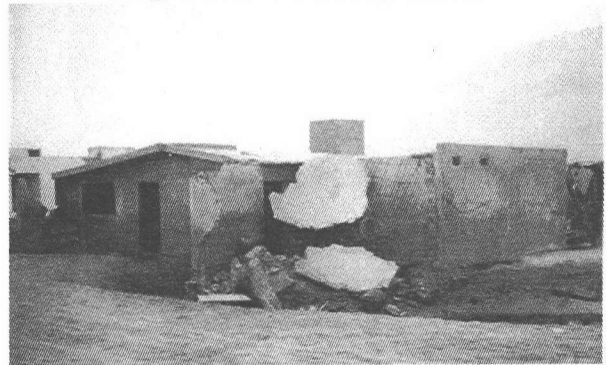
Figure 22. Destroyed dwellings by tsunami

The dark colored zone in **Figure 21** is considered to have been inundated with water. The surges destroyed a great number of dwellings, hotels and restaurants there (**Figures 22** and **23**). The inundated zone was covered thin with wet fine silty soils suggesting that the water surged over the zone was stopped there for a while as is shown in **Figure 24**. From a number of RC columns pushed down, possible directions of tsunami surges were estimated (**Figure 25**).

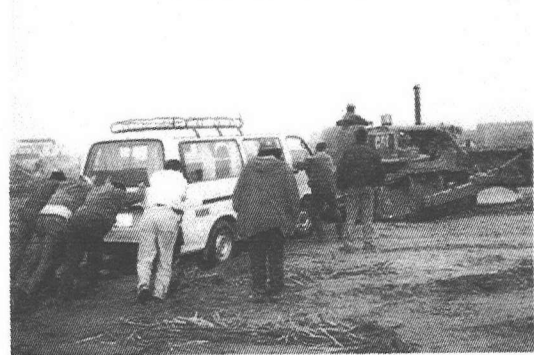
Figure 23. A car caught in soft silty soils

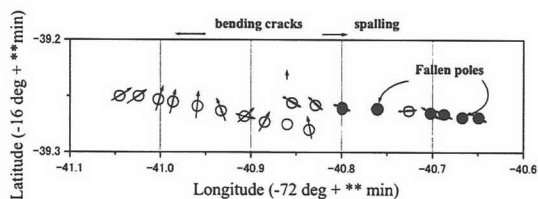
Figure 28. Spalled and cracked utility poles

Direction of the surge was also estimated from spalled utility poles (Figure 26). Two lines of utility poles along the coast were examined. Most poles on the front were still standing almost upright while those about 100m inland were more or less tilted because their foot soils were scoured by the surge. Probably for this reason, spalled poles were mostly found on the front (one-head arrows). Lateral hair cracks were found on some poles, which seemingly suggest that the poles have experienced lateral shake before the area was inundated. The two-heads arrows show inferred directions of strong ground motion, which seem to have been intense in about EW direction.
