大震災に学ぶ

——阪神・淡路大震災調査研究委員会報告書——

Lessons from the Hanshin-Awaji Great Earthquake Disaster

第 I 卷 Vol. I

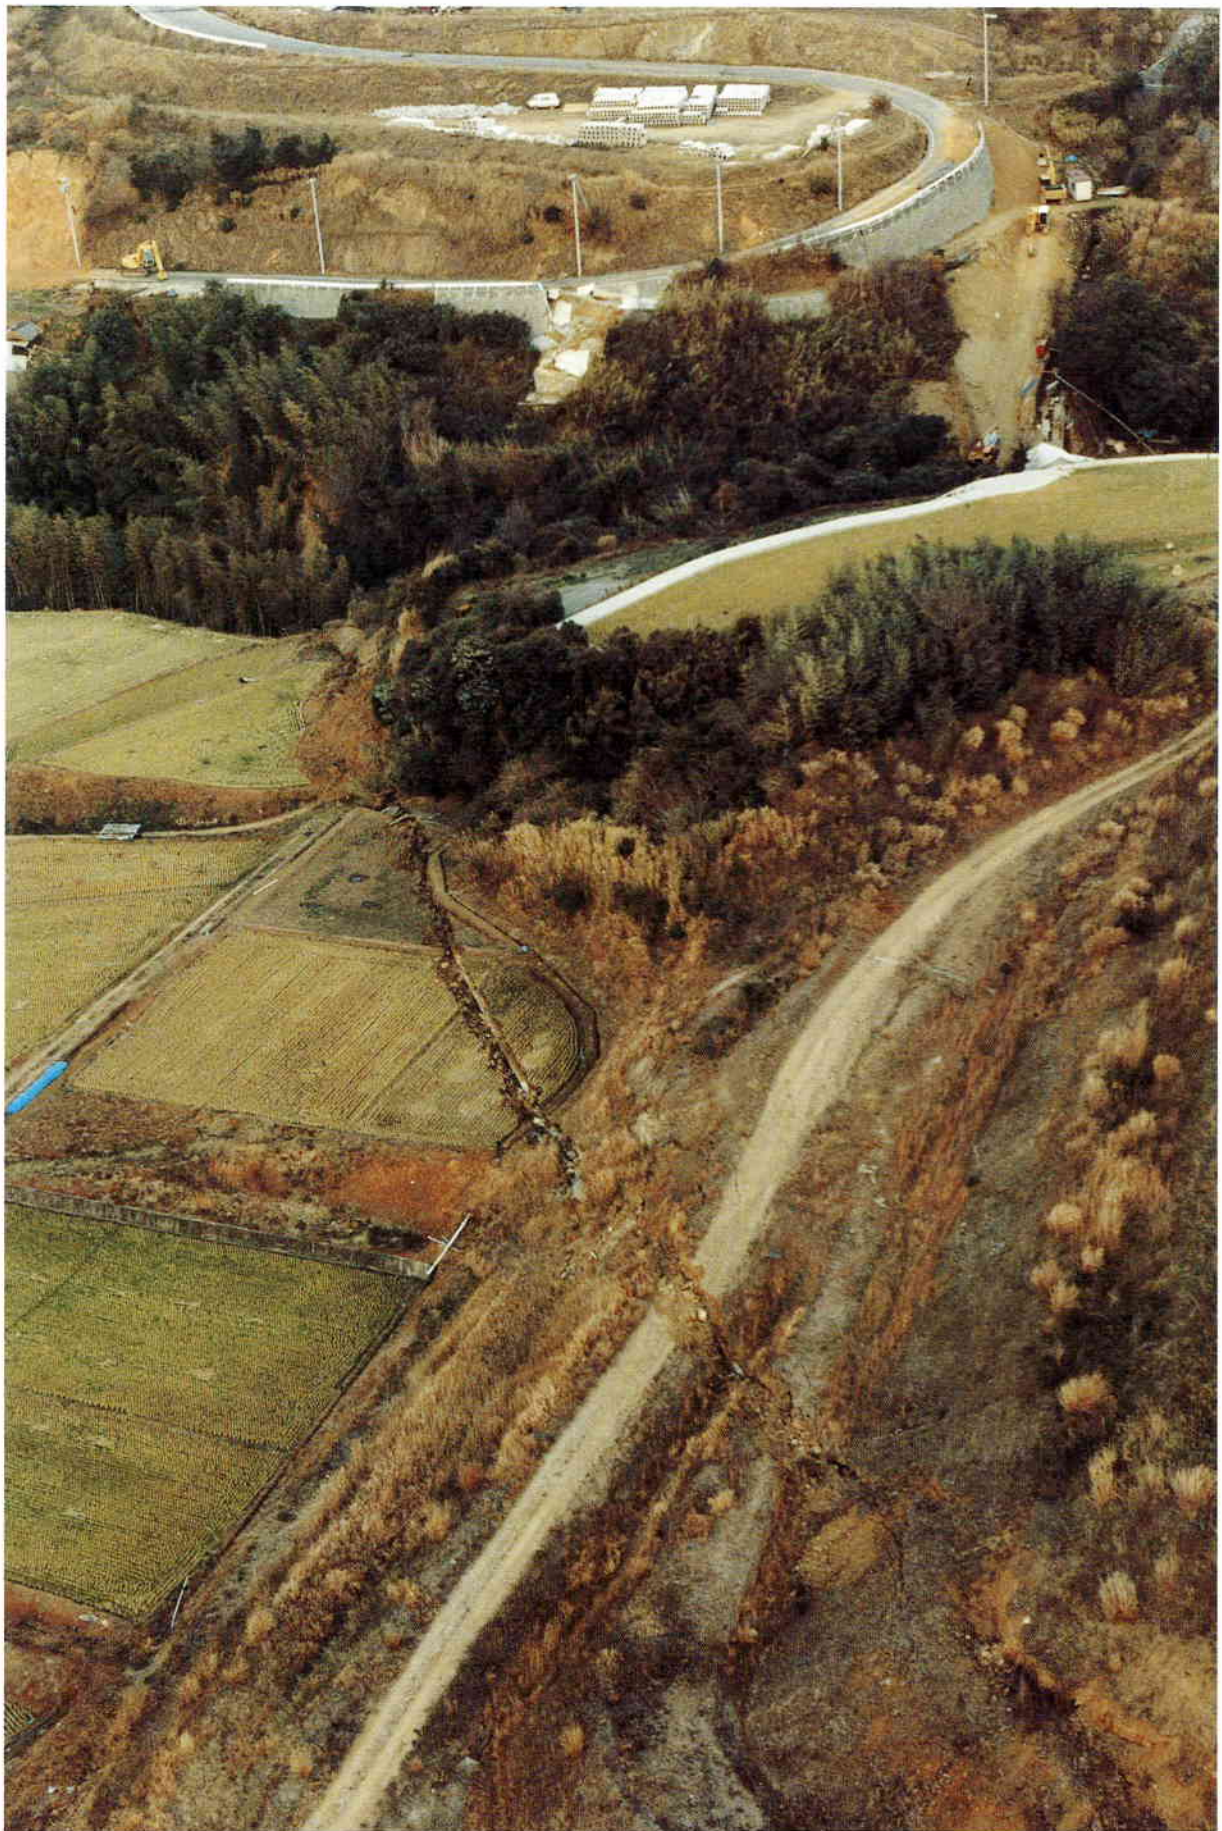
写真-3. 2. 1 北淡町平林に現れた野島地震断層(朝日新聞社、1995年1月18日午後4時頃撮影) 北方を望む

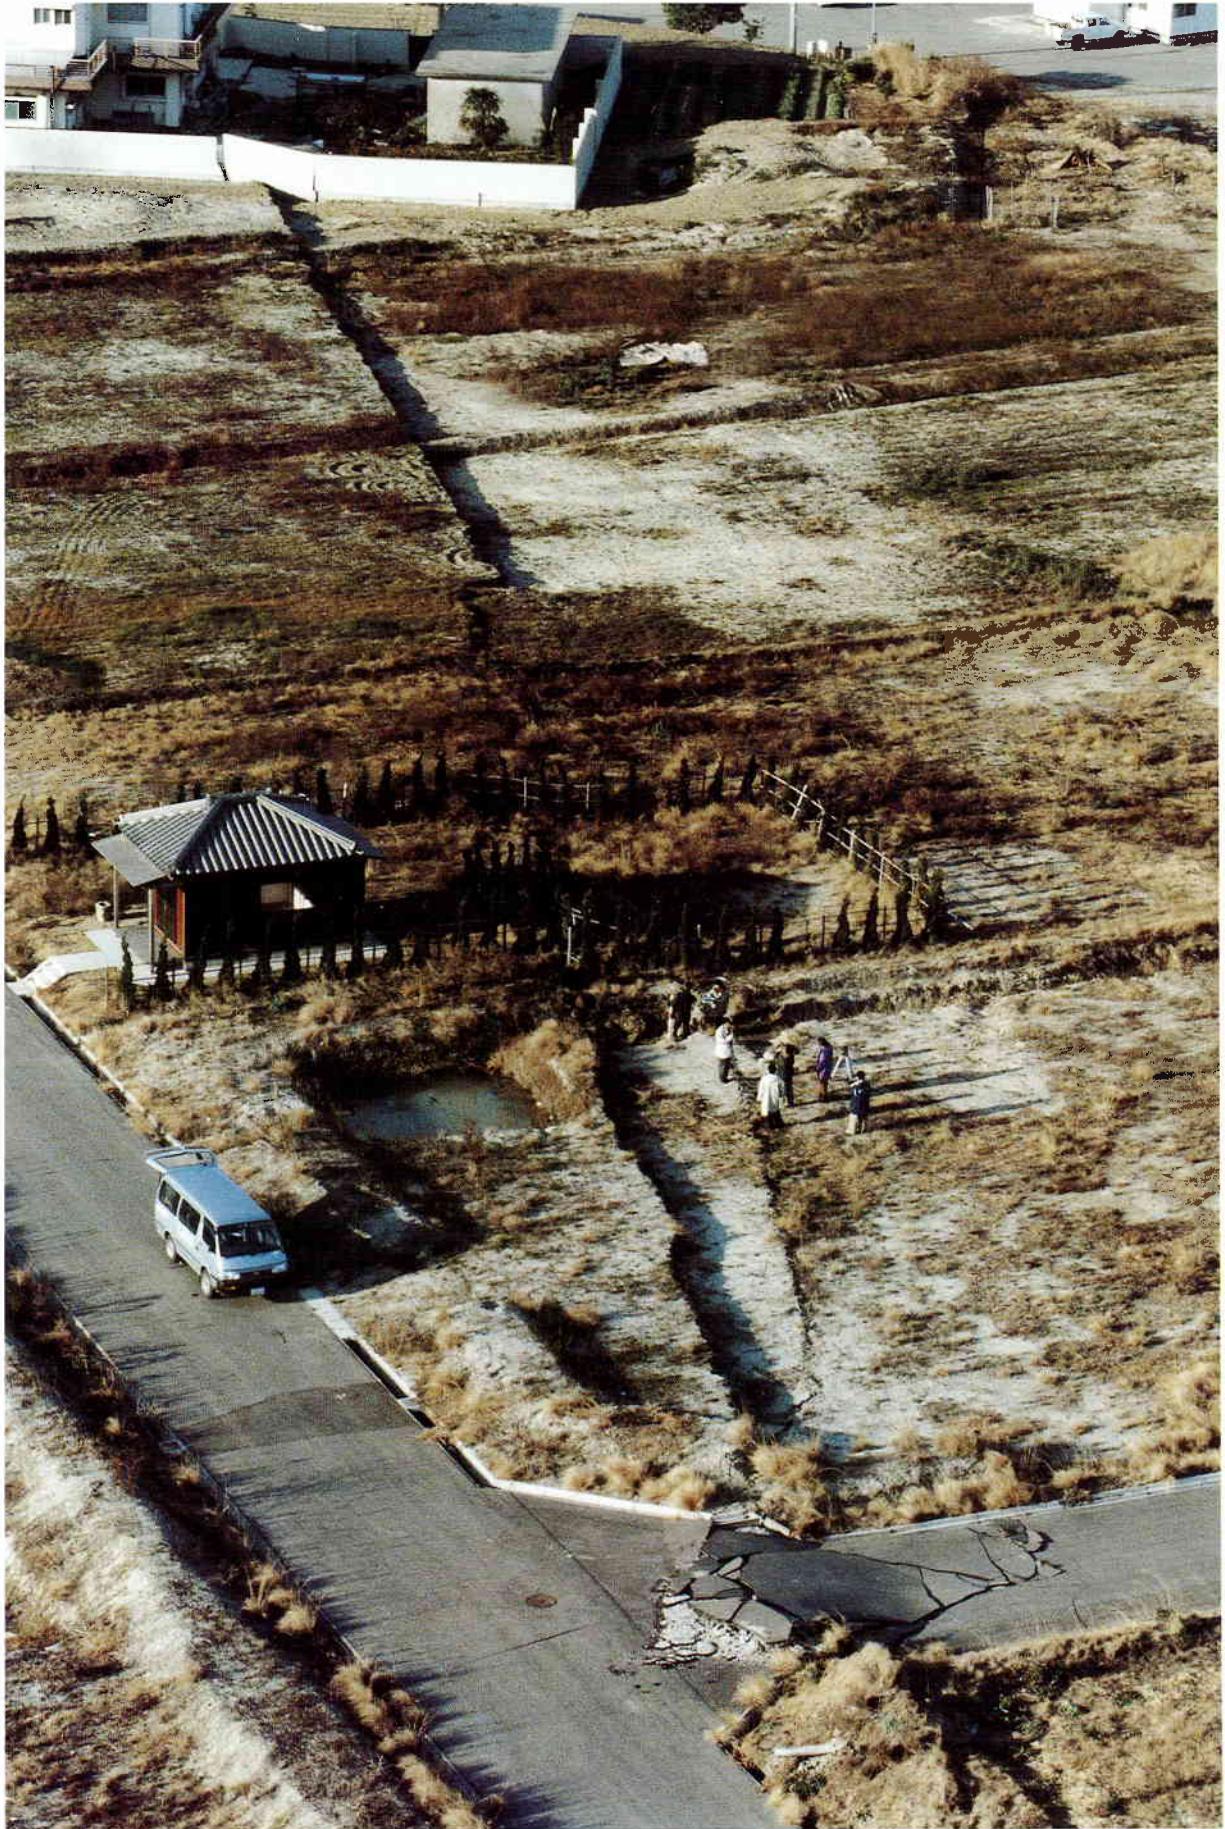
写真-3. 2. 2 北淡町小倉に現れた野島地震断層(産経新聞社、1995年1月19日早朝撮影) 南方を望む

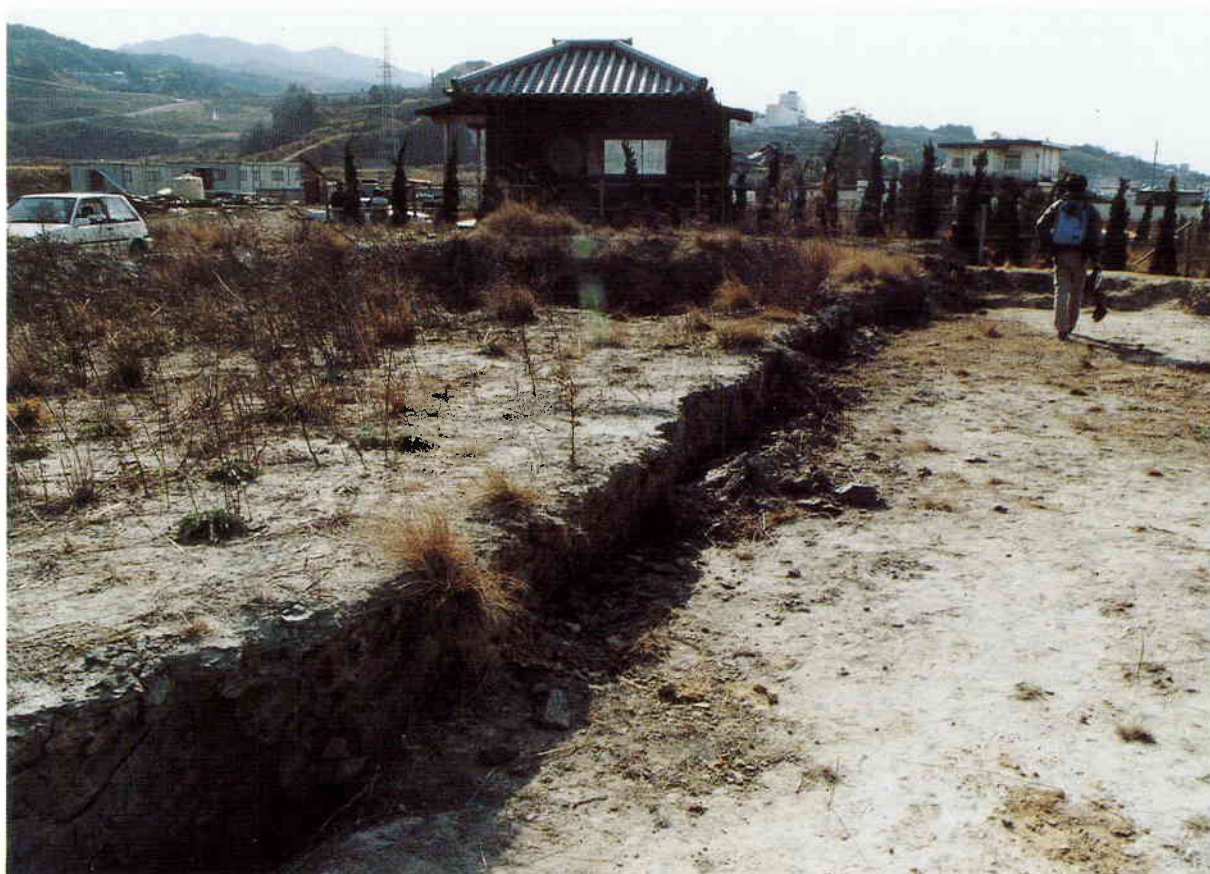
写真-3. 2. 3 北淡町小倉における地震断層の状況(1995年1月29日岡田撮影) 南方を望む

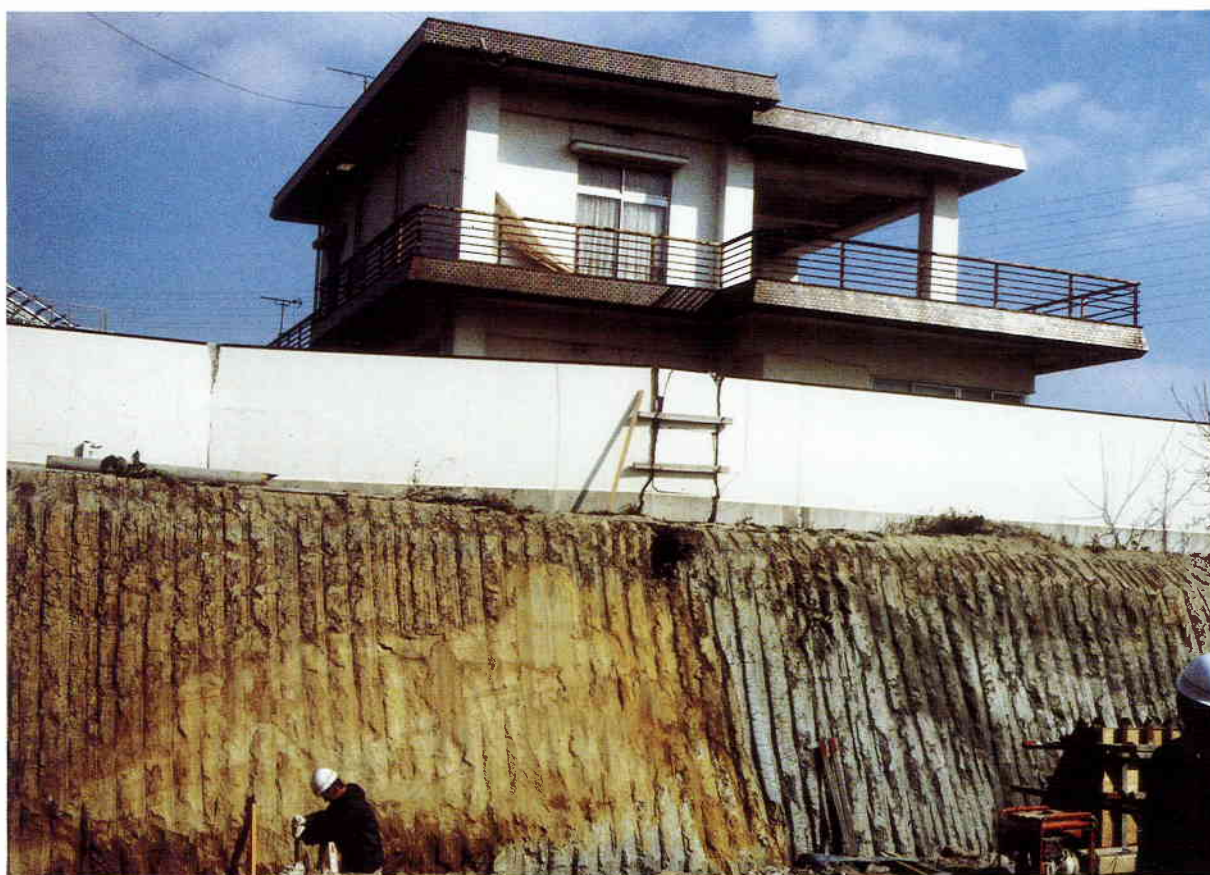
写真-3. 2. 4 北淡町小倉の野島断層の露頭(1998年1月31日岡田撮影) 北方を望む

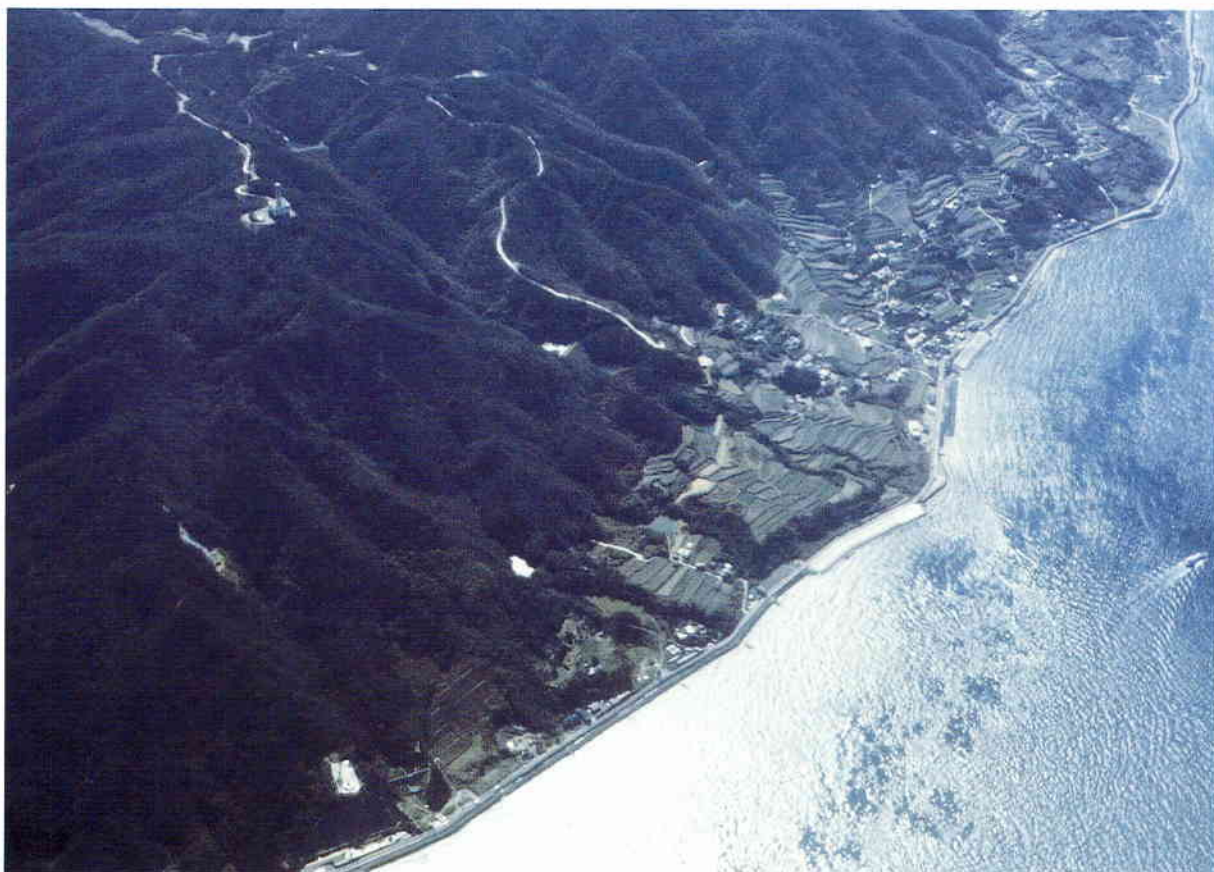
写真-3. 2. 5 野島断層北部の斜め空中写真(1998年2月27日岡田撮影) 南東を望む

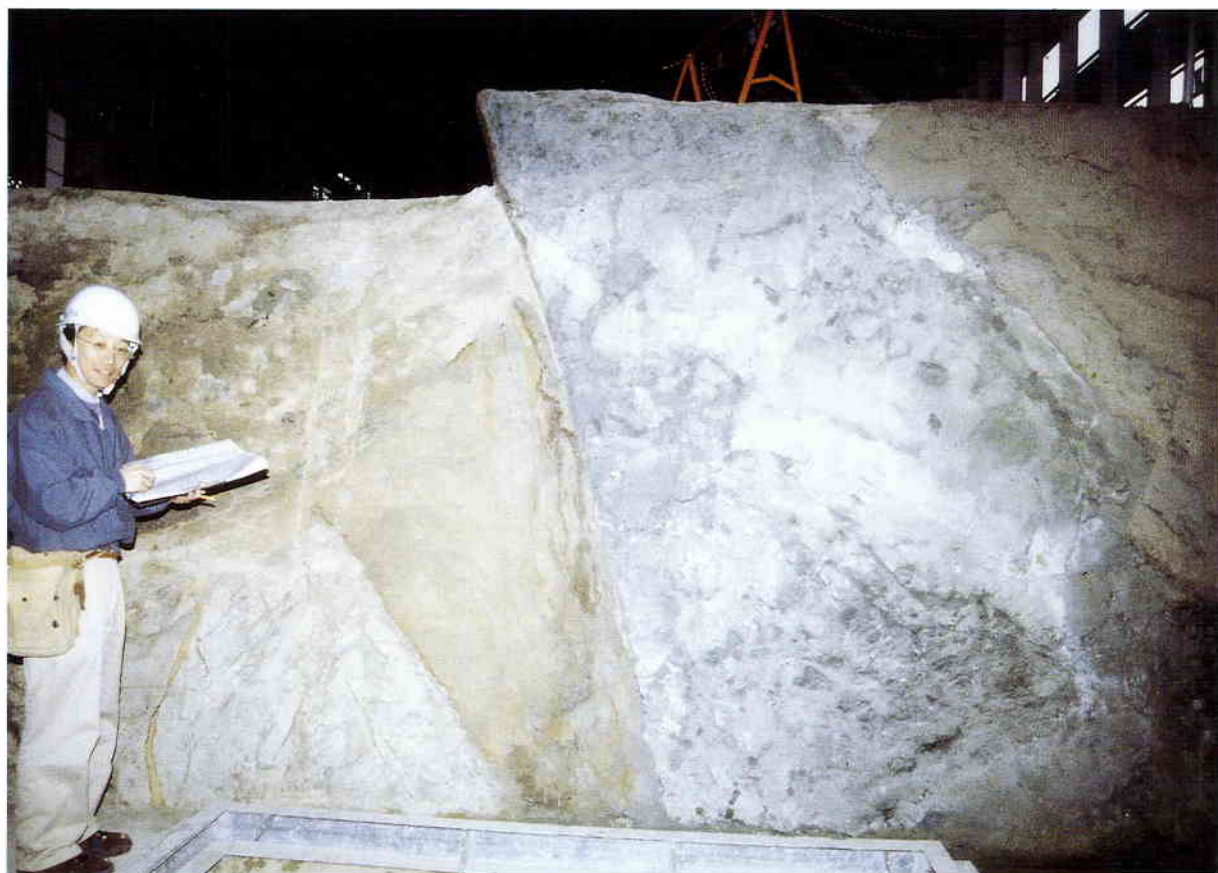
写真-3. 2. 6 野島地震断層保存館内の北側トレンチ法面(1998年2月7日岡田撮影)

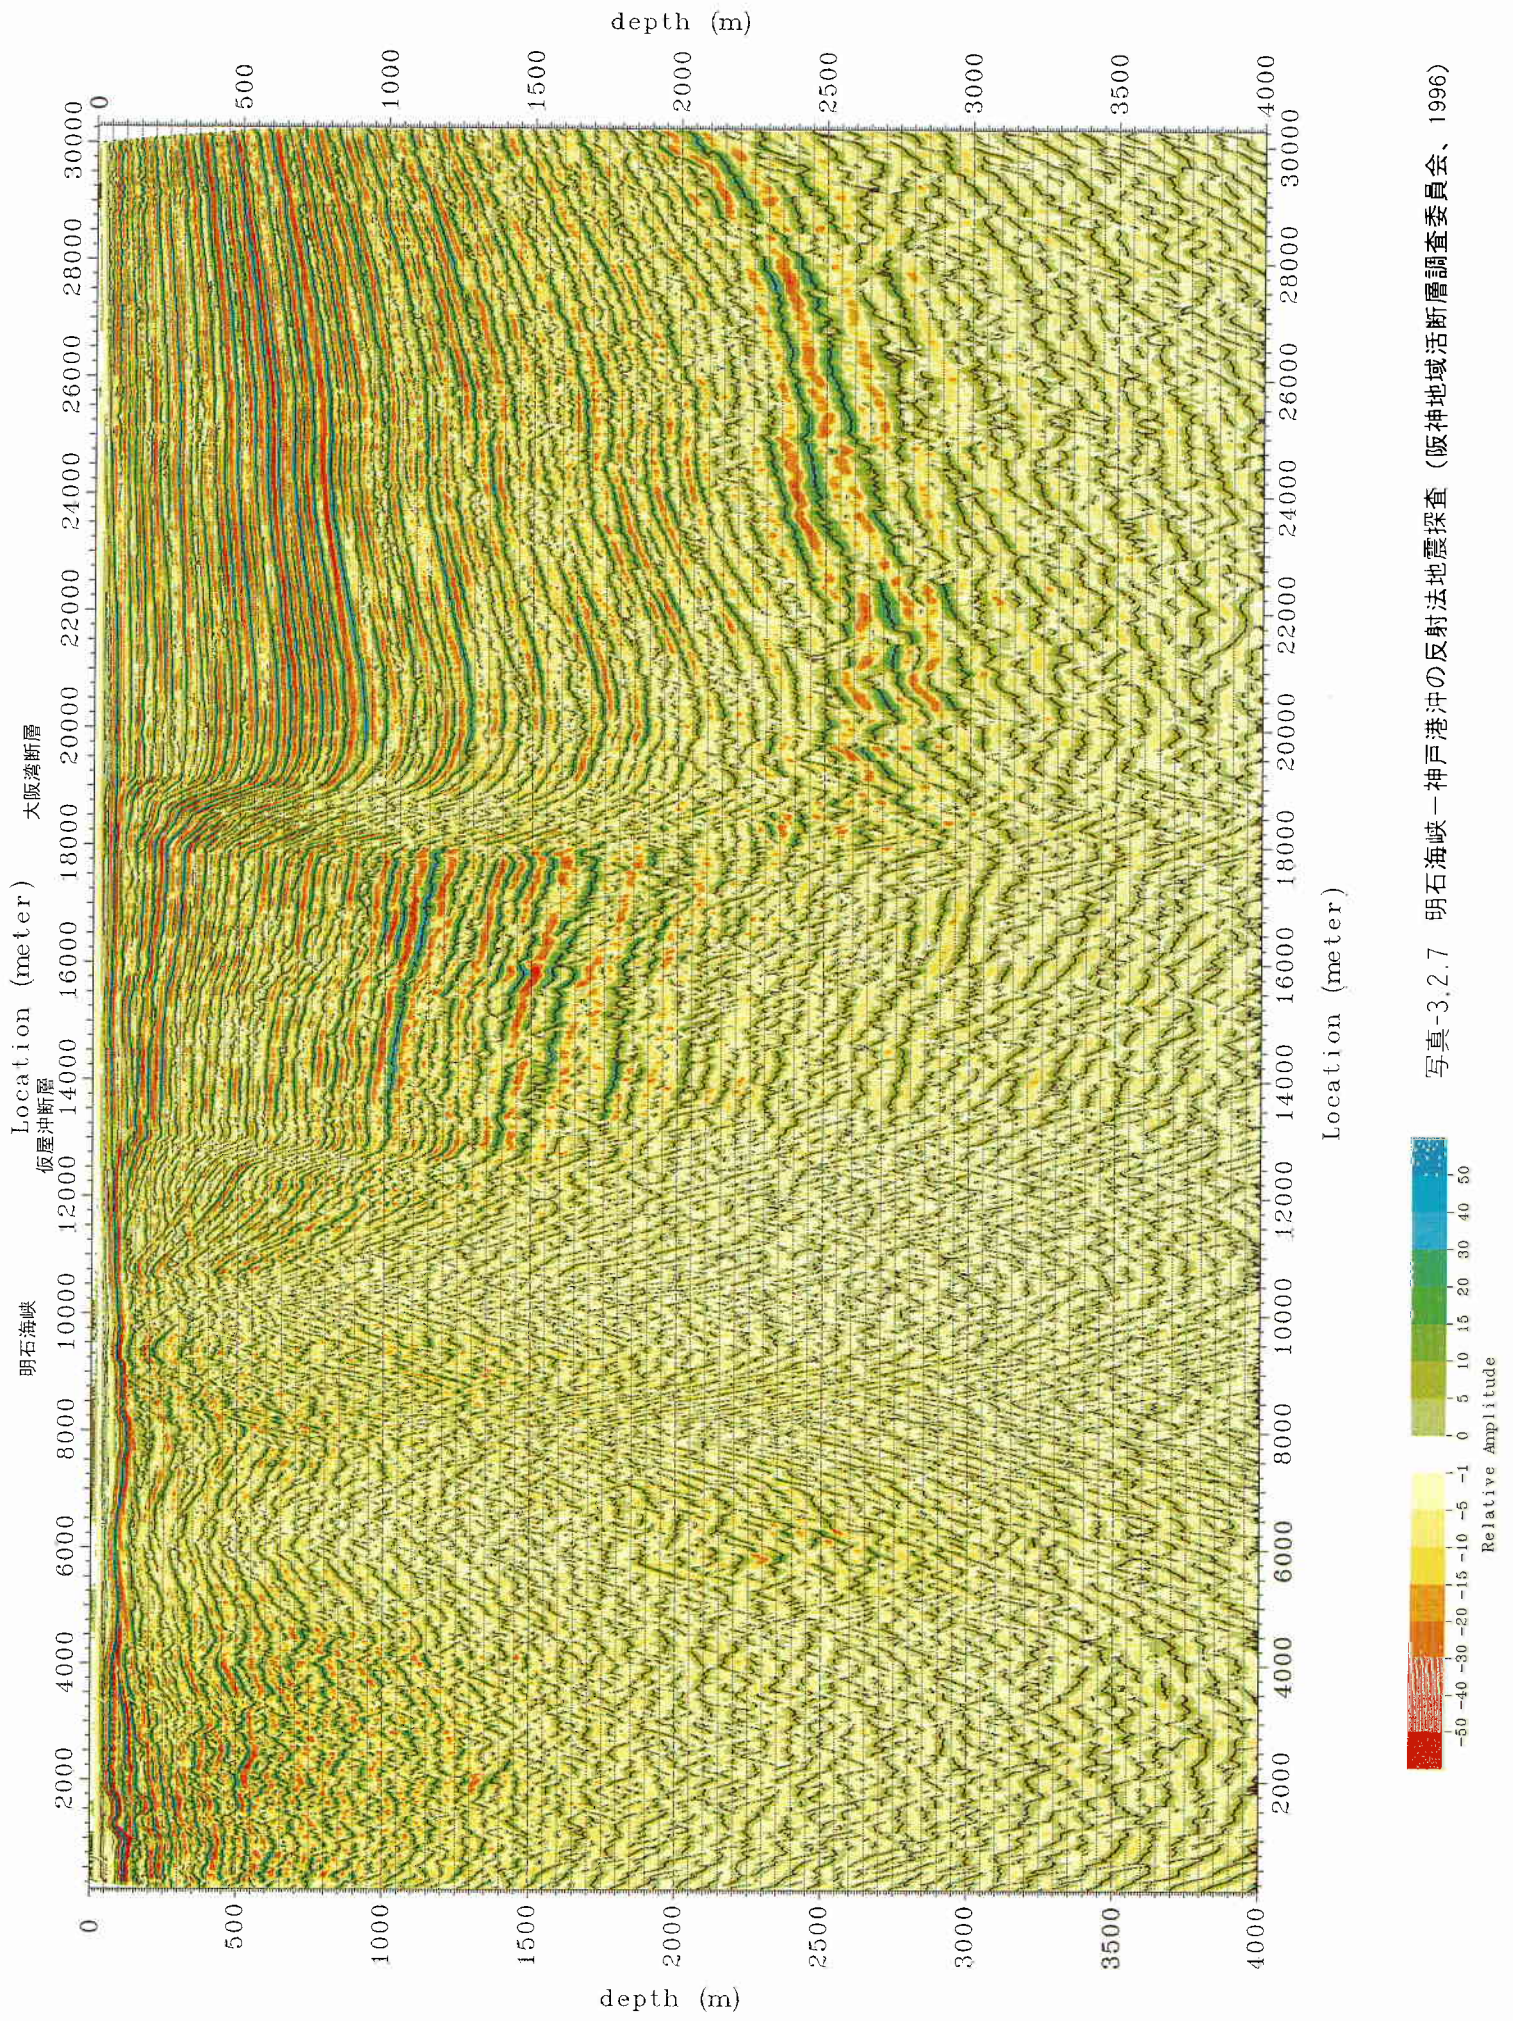
写真-3.2.7 明石海峡-神戸港沖の反射法地震探査 (阪神地域活断層調査委員会、1996)

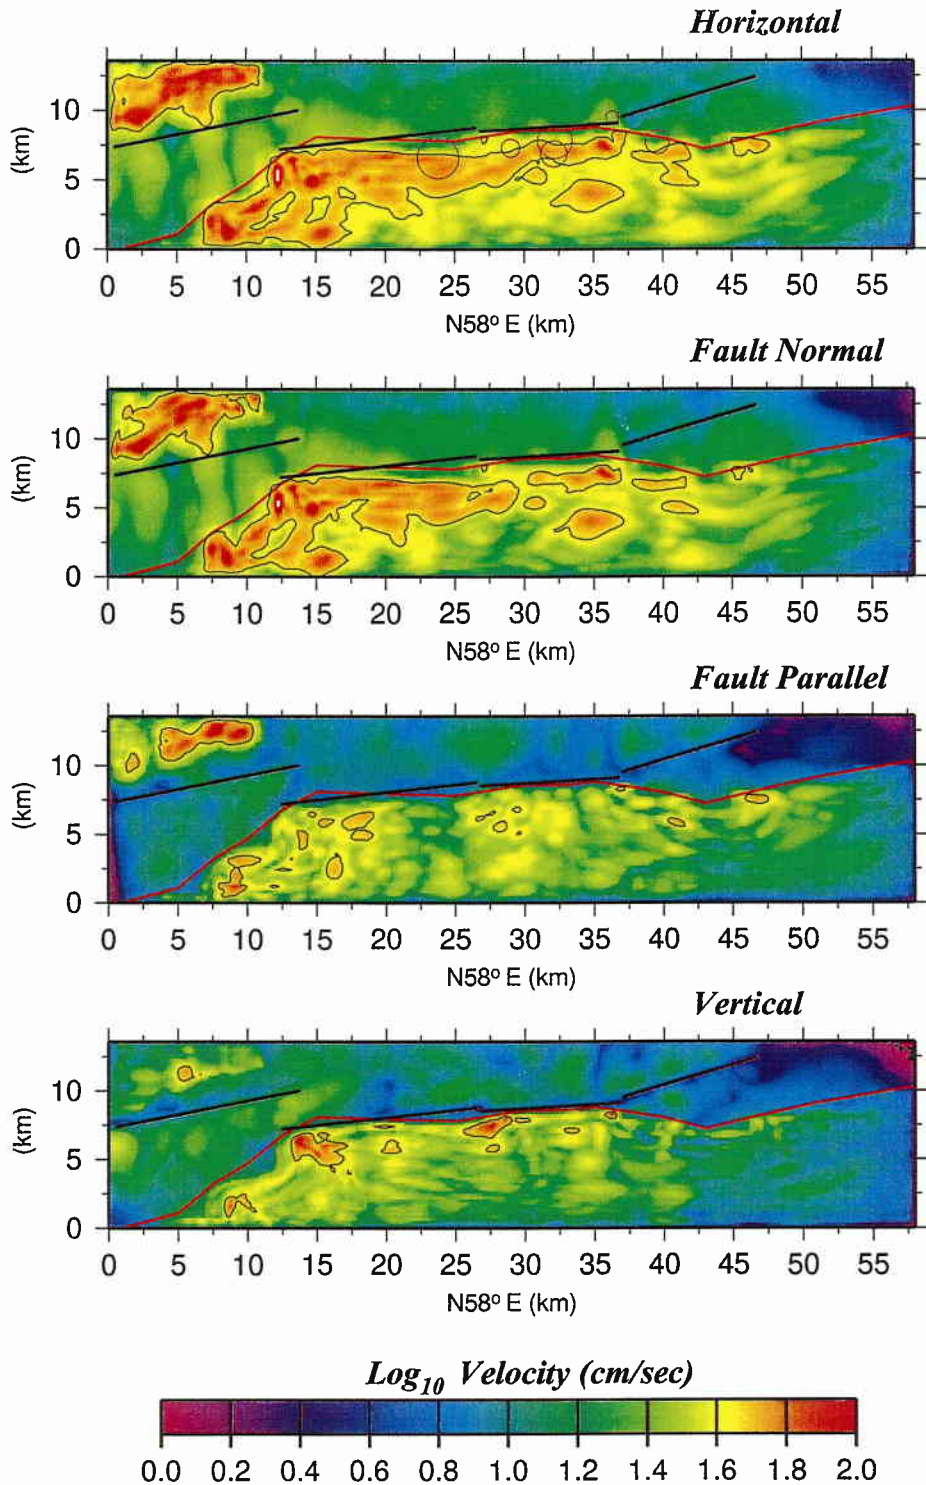
図-6.5.2 3次元構造モデル(図-6.4.8)とインバージョンによる震源過程(図-6.2.7)を想定したとき震源断層の周辺の地震動の最大速度の分布。
上から断層直交水平動、断層平行水平動、水平最大動、そして上下動。
