# MECHANISM OF DAMAGE TO SHIWEI BRIDGE CAUSED BY 1999 CHI-CHI EARTHQUAKE

The Shiwei Bridge in Taiwan was extensively investigated in order to determine the reasons for its failure during the 1999 Chi-Chi Earthquake. Our field investigation revealed no evidence of horizontal displacement in any of the bridge's piers, although the foundations of the piers were rotated. Two possible scenarios for the failure of the girders are proposed: 1) when the foundations rotated, the distance between the piers became greater than the length of the girder, causing the girders to fall; or 2) the direction of the seismic motion was perpendicular to the axis of the bridge, causing the girders to rotate and fall.

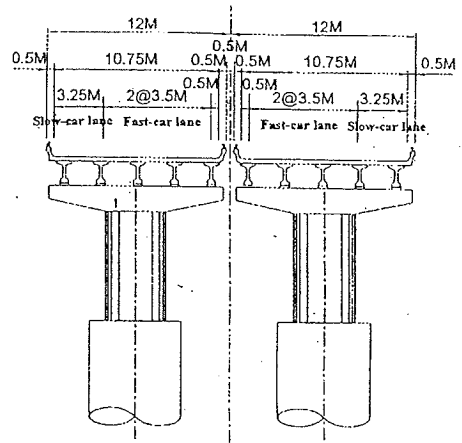
Fig.2 Elevation of SHI-WEI Bridge

The elevation of the Shiwei Bridge is shown in Fig. 2. The bridge curves at angles ranging from 55° to 85°, as shown in Fig. 3.
