## Brief Review of the June 23, 2001 Atico Earthquake, Peru

Kazuo KONAGAI<sup>1</sup>, Kimiro MEGURO, Junichi KOSEKI, Kenichi OHI,  
Shunichi KOSHIMURA<sup>2</sup>, Miguel ESTRADA<sup>1</sup>, Jorgen JOHANSSON<sup>1</sup>,  
Paola MAYORCA<sup>1</sup>, Ruben GUZMAN<sup>1</sup> and Tomohiro KIMURA<sup>3</sup>

Atico Earthquake occurred off the coast of southern Peru, about 175 km west of Arequipa or about 595 km southeast of Lima at 4:33 PM EDT on Jun 23, 2001 (3:33 PM local time in Peru). In this earthquake, total 41,394 dwellings were reportedly destroyed or heavily damaged. In urban areas, more than 80% of the housing infrastructures are made of masonry and adobe/tapial while in rural areas almost 70% of the dwellings are made of the latter. Though tragic, the death toll was fairly light considering the magnitude of this earthquake, the largest one to occur anywhere in the world in the past 25 years, and the damage seemed to be greatly localized even in a small area. This report outlines the findings obtained through the reconnaissance survey and some comments by some individuals

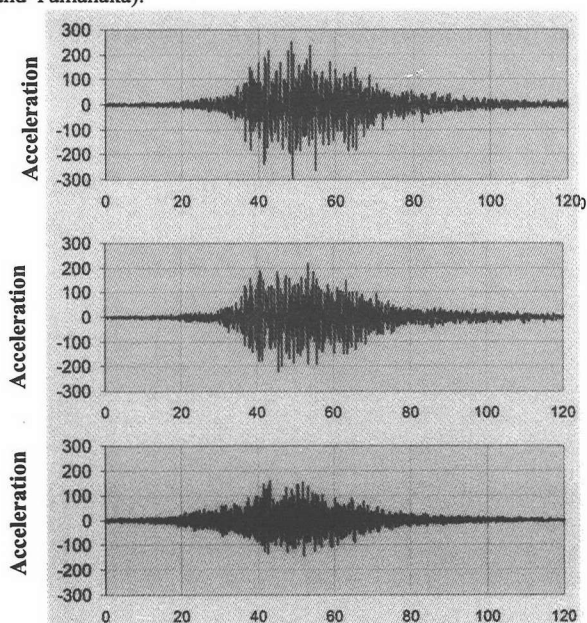
Figure 2. Acceleration time histories at Moquegua

CISMID (Japan-Peru Center for Earthquake Engineering and Disaster Mitigation) has recovered and processed the information from only one instrument that triggered in Peru, the one in the city of Moquegua. Two other instruments in the epicentral area apparently malfunctioned. Figures 2 and 3 show the corrected ground acceleration time histories and the corresponding acceleration response spectra obtained from that instrument recording in East-West, North-South, and Vertical directions.

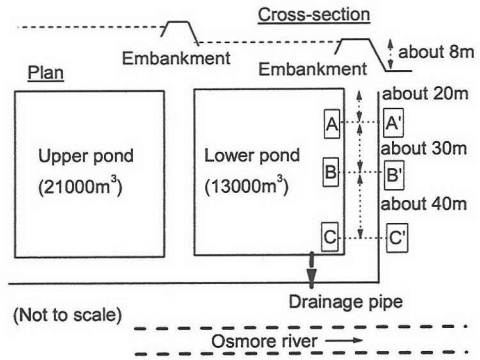
**Figure 13.** Plan of two oxidation ponds for sewage treatment

**Figure 13** shows a plan of two oxidation ponds for sewage treatment in Moquegua. The upper and lower ponds have a capacity of 21000 and 13000 m<sup>3</sup>, respectively, and have been cleaned every ten years. Their bottom is sealed with clay layer. By the earthquake, the embankment on the downstream side of the lower pond suffered cracking in its crest (**Figure 14, left**).

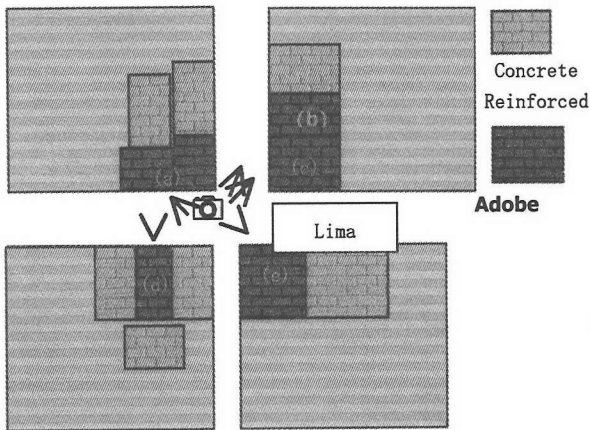
Figure 20. Sketch showing location of Points (a)-(e).

Structures of adobe performed in general badly as observed in many other earthquakes. Below follows a sketch and some figures showing collapsed adobe structures whereas neighboring reinforced masonry structures suffered on only minor damage (Figure 20). Points (b) and (c) show that a corner of an adobe structure is a weak point.

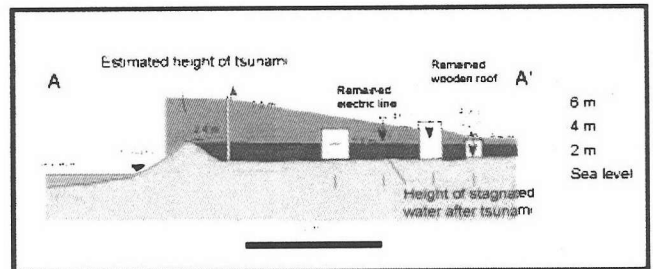
Figure 24 Variation of estimated tsunami height along AA' line in Figure 25.

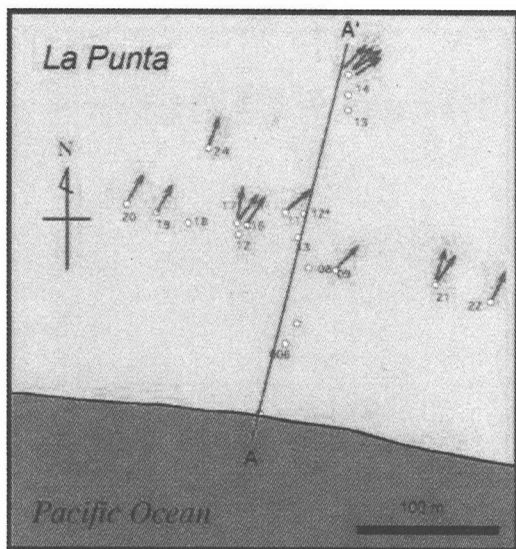
The dark colored zone in **Figure 21** is considered to have been inundated with water. The surges destroyed a great number of dwellings, hotels and restaurants there (**Figures 22** and **23**). The inundated zone was covered thin with wet fine silty soils suggesting that the water surged over the zone was stopped there for a while as is shown in **Figure 24**. From a number of RC columns pushed down, possible directions of tsunami surges were estimated (**Figure 25**).

Figure 25. Possible directions of tsunami surge
