PROPOSAL OF A NEW ECONOMIC RETROFITTING METHOD FOR MASONRY STRUCTURES

Paola MAYORCA¹ and Kimiro MEGURO²

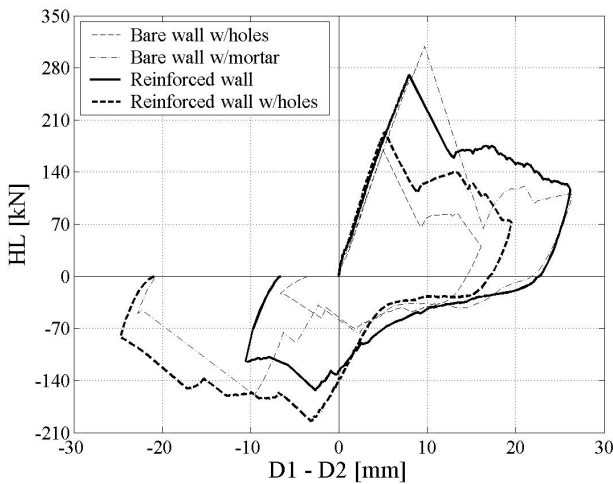
Figure 2. Force-deformation curve (VL=9kN)

Photos 2 and **3** show typical crack patterns. **Figures 2** and **3** show the force-deformation curves obtained in the experiments grouped according to the pre-compression load. The experimental observations are briefly discussed below.

The force-deformation curves presented in **Figure 2** may suggest that the reinforced walls have a slightly higher stiffness than the unreinforced ones. However, it must be noted that the deformations showed in the figures correspond to two effects, the wall deformation itself and the wall rotation. The later is larger. **Figure 4** shows the deformation along the wall diagonals, which is a direct measurement of the wall shear deformation. Note that the deformation of both reinforced and unreinforced

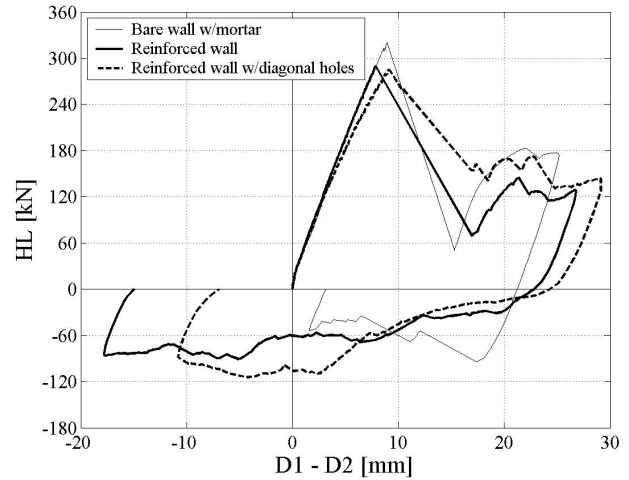
Figure 3. Force-deformation curve (VL=30kN)

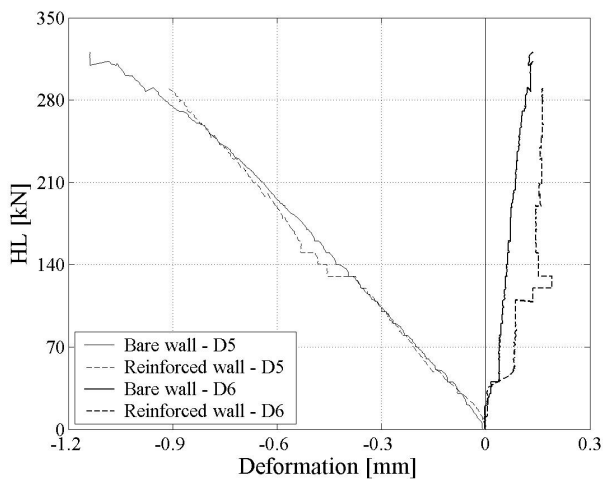
Figure 4. Diagonal deformation (VL=30kN)

walls is small and almost the same. This shows the high stiffness of the masonry wall and suggests that the stiffness difference observed in the force deformation curves is mainly due to the reinforcement restrain to the wall rotation.

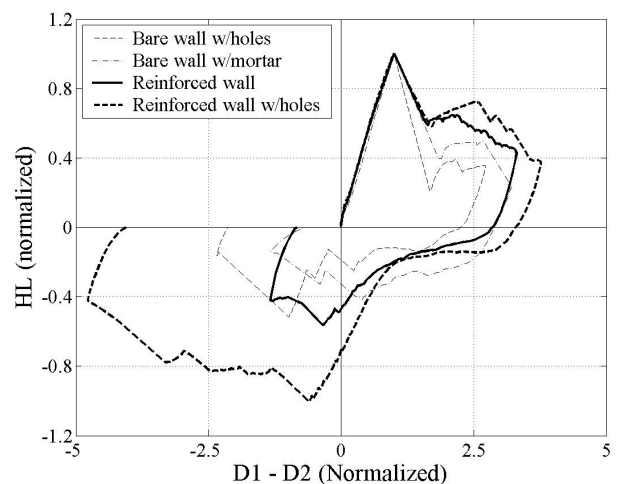
Figure 5. Normalized force-deformation relation (VL=9kN)

Figure 5 shows the force-deformation relation normalized to the peak strength and corresponding deformation for the group of walls with VL=9kN. It is observed that immediately after the peak, the normalized strength dropped to 10 to 40% for the unreinforced walls. On the other hand, the reinforced walls exhibited a 60% residual strength after the peak, which was sustained even for large deformations. In the reverse direction, the reinforced walls also exhibited a larger normalized strength.
