STRUCTURAL EVALUATION FOR AIRPORT ASPHALT PAVEMENTS WITH EARTHQUAKE INDUCED CRACKS

Two aspects were included in this paper: (1) evaluating the seriousness of earthquake induced cracks; (2) identifying the effectiveness of maintenance and rehabilitation (M&R). Firstly, through a theoretical analysis of elastic three-layer pavement model, pavement deflections D_{45} as well as D_{250} under FWD loading conditions at cracked and uncracked sections were recommended as indices to evaluate the seriousness of cracks. By means of statistical test, the structural evaluation procedure was proposed. Its validity was verified by coring tests. Then, by comparing the FWD deflections before and after M&R, the effectiveness of sealing, patching and overlay was identified.

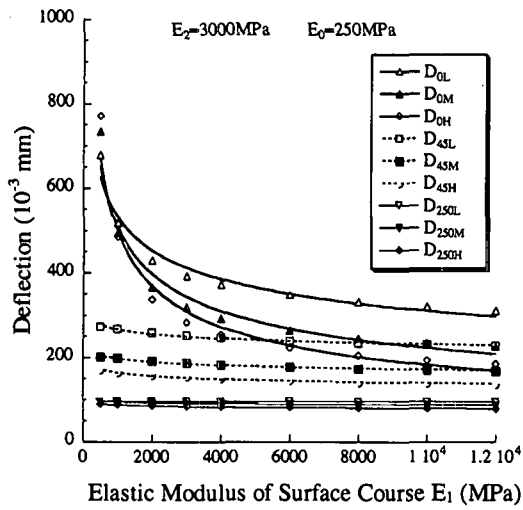
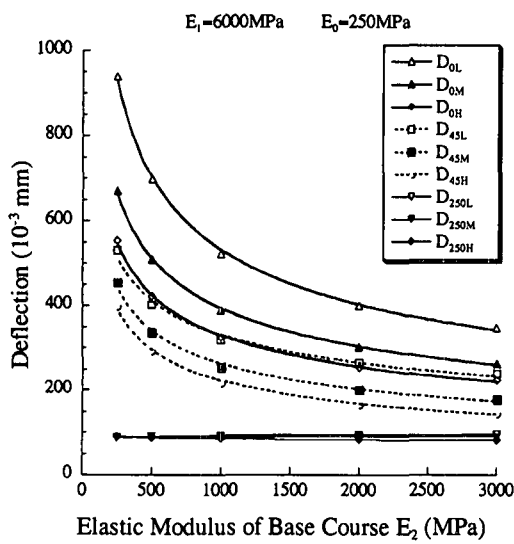
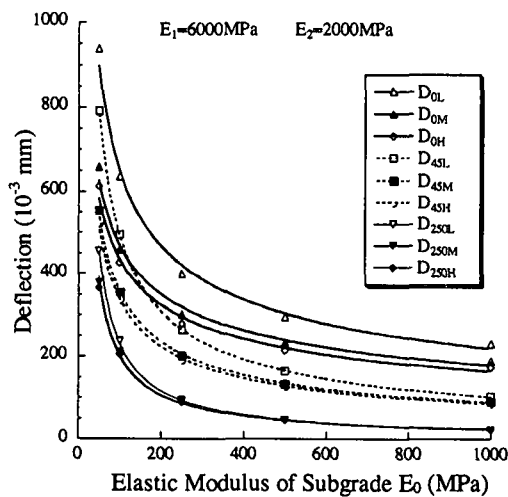
a) Surface course

b) Base course

c) Subgrade

Fig. 5. Relationship between pavement deflections with elastic modulus

The results of theoretical analysis were demonstrated in Fig. 5, in which L, M and H represent pavement with thin, medium and thick structures, respectively.

From Fig. 5, the following relationships are found. As the elastic modulus of surface course decreases, D_0 increases, whereas D_{45} has relatively smaller increase and D_{250} almost keeps constant. To the contrary, as the elastic modulus of subgrade decreases, all deflections including D_{250} increase significantly. Moreover, as the elastic modulus of base course decreases, D_{250} almost keeps constant, whereas both D_0 and D_{45} increase significantly.

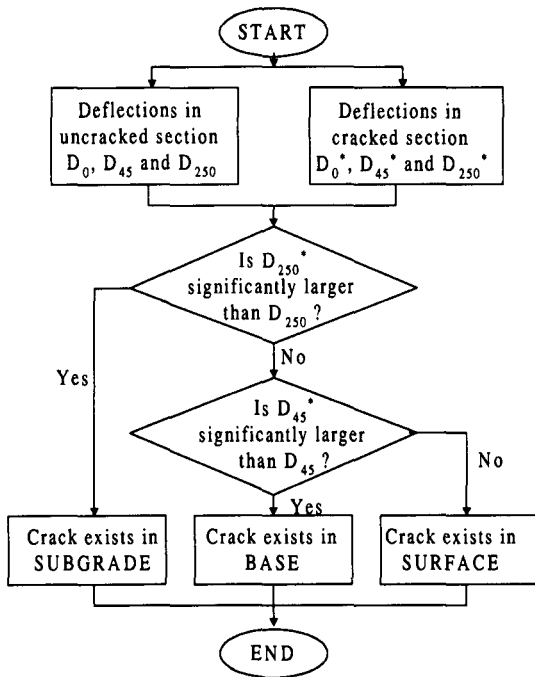
Fig. 6 Flow chart for evaluating the seriousness of crack

For evaluating the seriousness of cracks, two FWD measurements must be conducted: far away from the crack and near the crack. The following procedure is recommended to make such an evaluation:

- 1) Comparing D_{250} of uncracked section with that of cracked section, if the latter is significantly larger than the former, there must be a lower elastic modulus in the subgrade of the cracked section. So, the crack may exist in the subgrade.

- 2) If no significant difference exists between the two D_{250} values, compare D_{45} of uncracked section with that of cracked section. Similarly, if the latter is significantly larger than the former, there must be a lower elastic modulus in the base course of the cracked section. So, the crack may exist in the base course.

The evaluation procedure was illustrated by a flow chart as shown in Fig. 6.

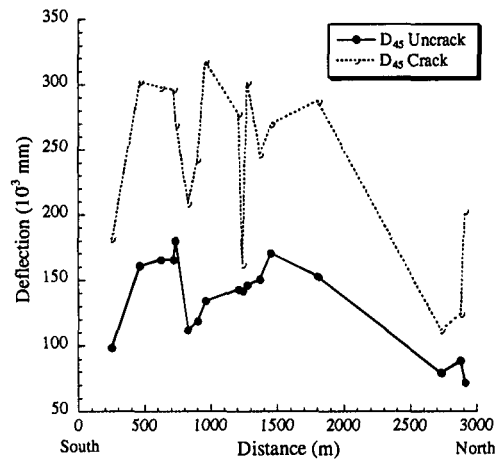
a) D_0

b) D_{45}

c) D_{250}

Fig. 7 Distribution of deflections

Fig. 7 demonstrates the distribution of FWD deflections D_0 , D_{45} as well as D_{250} at cracked and uncracked sections in runway B. It shows that the deflection D_0 and D_{45} in cracked sections are obviously larger than that of uncracked sections, whereas D_{250} does not have such a phenomenon obviously.

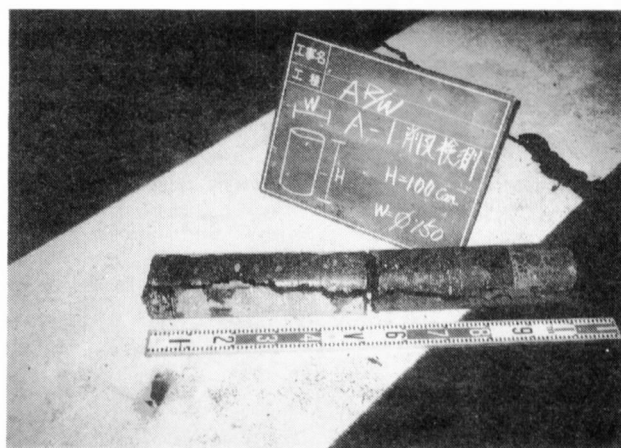
**Fig. 9** Coring test result of the example

The pavement structure and coring test result of the example are shown in **Fig. 8** and **Fig. 9**. The FWD deflections are listed in **Table 3**.

By using Eq. (1), as its deflection D₂₅₀ at cracked section is significantly larger than that of uncracked section, the crack is evaluated to be located in subgrade. Coring test confirms the evaluation result.
